# Access Compliance Report

### (Curb Ramps)

| Intersection ID: 47450 | Main Street: PINTAIL_LANDING_LN | Cross Street: MALLARD_LANDING_RD | Location: NE |
| ADA ID: A1ABEBC54631 | Ramp Type: PerpDiag | Initial Pass/Fail: Fail | Overall Compliance: No |

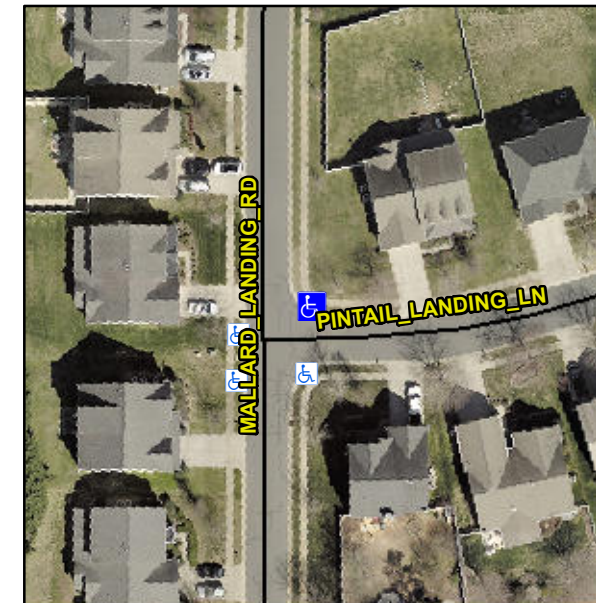
**R304.5.1, R304.5.3**

| Compliance | Description | Data | Compliance | Description | Data |
|---|---|---|---|---|---|
| N/A | Ramp Length (in) | 47.0 | Yes | Ramp Slope (%) | 7.4 |
| No | Ramp Width (in) | 45.0 | No | Ramp XSlope (%) | 4.1 |

**Remove & Replace Curb Ramp With Two New Directional Ramps or Equivalent.**
