# Access Compliance Report

## Public Rights-of-Way

### (Curb Ramps)

| Intersection ID: 3245 | Main Street: HERITAGE_HILLS_LN | Cross Street: MARATHON_HILL_RD | Location: SE |

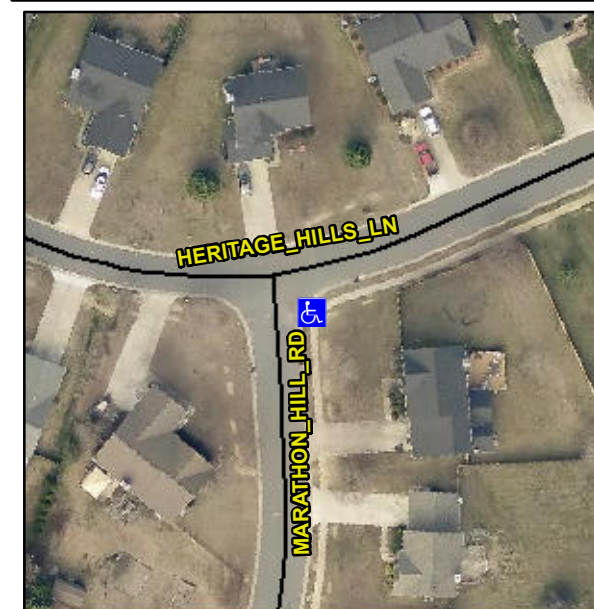
| ADA ID: A1B2CEF269A7 | Ramp Type: Perp | Initial Pass/Fail: Fail | Overall Compliance: No |
| Severity Score: 8.75 | | | |

**R304.5.1**

| Compliance | Description | Data | Compliance | Description | Data |
|---|---|---|---|---|---|
| No | Ramp Width (in) | 44.0 | Yes | Ramp XSlope (%) | 0.9 |

**Remove & Replace Entire Ramp.**

**\$ 1850.00**
