# Access Compliance Report

## Public Rights-of-Way

### (Curb Ramps)

Intersection ID: 31673	Main Street: NEW_DAY_CT	Cross Street: STARSHINE_DR	Location: NE
ADA ID: A1BA6D24A4F4	Ramp Type: PerpDiag	Initial Pass/Fail: Fail	Overall Compliance: No
Severity Score: 22.5			
Codes/Mitigation Info/Possible Solution		Field Measurements/Component Compliance

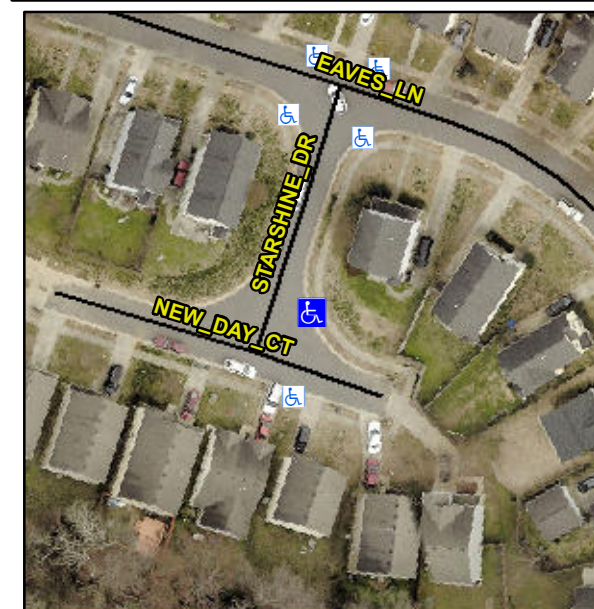
**Not Found, R304.5.1, R304.2.2, R304.5.3**

Compliance	Description	Data	Compliance	Description	Data
N/A	Ramp Length (in)	49.0	No	Ramp Slope (%)	8.6
No	Ramp Width (in)	45.0	No	Ramp XSlope (%)	4.1
N/A	Flare Type LT	N/A	N/A	Flare Type RT	N/A
N/A	Flare Slope LT (%)	N/A	N/A	Flare Slope RT (%)	N/A
N/A	Flare Traversable LT?	N/A	N/A	Flare Traversable RT?	N/A
N/A	Landing Length (in)	N/A	N/A	DWS Provided?	N/A
N/A	Landing Width (in)	N/A	N/A	DWS Contrast?	N/A
N/A	Landing Slope (%)	N/A	N/A	DWS Length (in)	N/A
N/A	Landing X Slope (%)	N/A	N/A	DWS Full Width?	N/A
N/A	Landing Curb? (Y/N)	N/A	N/A	DWS Offset (in)	N/A
N/A	Shared Landing?	N/A			
N/A	Gutter Ponding?	N/A	N/A	Gutter Slope (%)	N/A
N/A	Gutter Lip Ht (in)	N/A	N/A	Gutter X Slope (%)	N/A
N/A	Painted X Walk1?	No	N/A	Painted X Walk2?	No
	X Walk 1 Direction	To NW		X Walk 2 Direction	To SW
N/A	X Walk 1 Width (in)	N/A	N/A	X Walk 2 Width (in)	N/A
	X Walk 1 Slope (%)	0.5		X Walk 2 Slope (%)	0.7
	X Walk 1 X Slope (%)	0.7		X Walk 2 X Slope (%)	2.7

N/A	Ramp inside XWalk1?	N/A	N/A	Ramp inside XWalk2?	N/A
	Road Slope (%)	2.5	N/A	Clear Space?	N/A
	Road X Slope (%)	0.5	N/A	Clear Space to XWalk (in)	N/A
N/A	Any Obstructions?	N/A	N/A	Storm Grate/Utility Hazard?	N/A
	Obstruction Type			Storm Grate/Utility Type	
		N/A			N/A
			Yes	Surface Condition? (G/P)	Good

**Remove & Replace Curb Ramp With Two New Directional Ramps or Equivalent.**
