Access Compliance Report Public Rights-of-Way (Curb Ramps)

Intersection ID: 10015839 Main Street: GLORY_ST Cross Street: N/A Location: **Overall Compliance: No Severity Score:** 12.5 **ADA ID: A1C475EACC75** Ramp Type: Directional1 Initial Pass/Fail: Fail

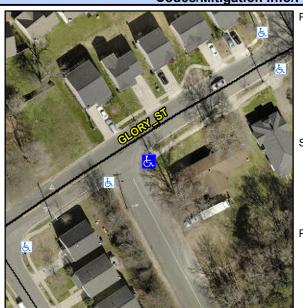
Field Measurements/Component Compliance						
Comp	liance Description	Data	Comp	liance Description	Data	
N/A	Ramp Length (in)	125.0	N/A	Grade Break?	N/A	
Yes	Ramp Width (in)	60.0	N/A	Grade Break Slope (%)	0.0	
No	Ramp Slope (%)	9.0	N/A	Grade Break XSlope (%)	0.0	
Yes	Ramp XSlope (%)	1.7				
N/A	Flare Type LT	N/A	N/A	Flare Type RT	N/A	
N/A	Flare Slope LT (%)	N/A	N/A	Flare Slope RT (%)	0.0	
N/A	Flare Traversable LT?	N/A	N/A	Flare Traversable RT?	N/A	
N/A	Landing Length (in)	0.0	N/A	DWS Provided?	N/A	
N/A	Landing Width (in)	0.0	N/A	DWS Contrast?	N/A	
N/A	Landing Slope (%)	0.0	N/A	DWS Length (in)	N/A	
N/A	Landing X Slope (%)	0.0	N/A	DWS Full Width?	N/A	
N/A	Landing Curb? (Y/N)	N/A	N/A	DWS Offset LT (in)	N/A	
N/A	Shared Landing?	N/A	N/A	DWS Offset RT (in)	N/A	
N/A	Gutter Ponding?	0.0	N/A	Gutter Slope (%)	N/A	
N/A	Gutter Lip Ht (in)	0.0	N/A	Gutter X Slope (%)	N/A	
N/A	Painted X Walk1?	No		Road Slope (%)	0.8	
	X Walk 1 Direction	To SW		Road X Slope (%)	7.7

Possible Solutions:
Remove & Replace Entire Ramp.
Surveyor Notes:
N/A
PROW/ADA:
R304.2.2
K304.2.2
