# Access Compliance Report

## Public Rights-of-Way

### (Curb Ramps)

| Intersection ID: 8463 | Main Street: JENNINGS_ST | Cross Street: LASALLE_ST | Location: SW |

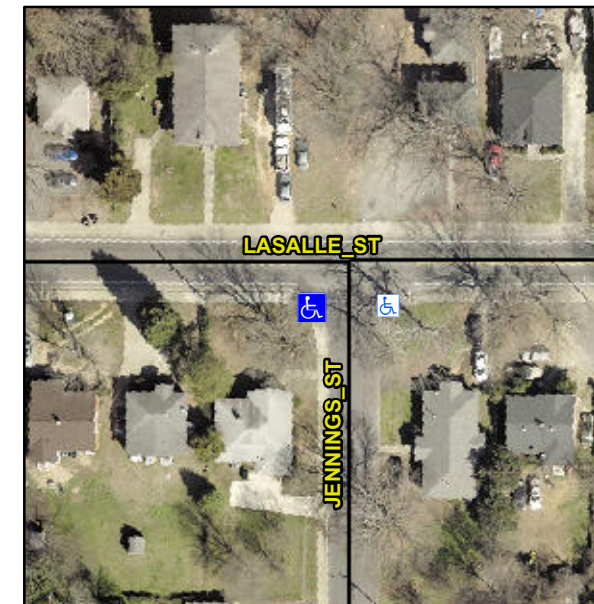
| ADA ID: A1DBC8E100FB | Ramp Type: Perp | Initial Pass/Fail: Fail | Overall Compliance: No |

**Not Found, R304.5.1, R304.2.2, R304.5.3**

| Compliance | Description | Data | Compliance | Description | Data |
|---|---|---|---|---|---|
| N/A | Ramp Length (in) | 61.0 | No | Ramp Slope (%) | 9.0 |
| No | Ramp Width (in) | 35.5 | No | Ramp XSlope (%) | 14.9 |

**Remove & Replace Entire Ramp.**

Total Cost: \$ 1850.00
