## **Access Compliance Report Public Rights-of-Way** (Curb Ramps)

Intersection ID: N/A Main Street: REA RD Cross Street: FAIRWAYS CLUB DR Location: SW **ADA ID: A1E02299FD7F** Ramp Type: PerpDiag Initial Pass/Fail: Fail **Overall Compliance: No** Severity Score: 33.75

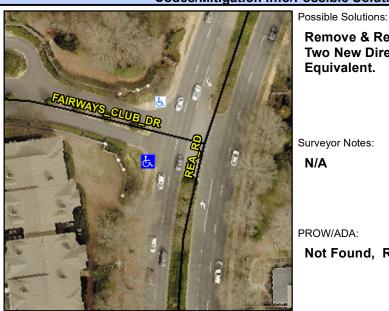
Not Found, R304.5.1, R304.5.3

Compliance Description		Data	Compliance		Description
N/A	Ramp Length (in)	52.0	Yes	Ramp Slope (%)	
No	Ramp Width (in)	47.5	No	Ramp XSlope (%)	
N/A	Flare Type LT	N/A	N/A	Flare	Type RT
N/A	Flare Slope LT (%)	N/A	N/A	Flare	Slope RT (%)
N/A	Flare Traversable LT?	N/A	N/A	Flare	Traversable RT?
N/A	Landing Length (in)	N/A	N/A	DWS	Provided?
N/A	Landing Width (in)	N/A	N/A	DWS	Contrast?
N/A	Landing Slope (%)	N/A	N/A	DWS	Length (in)
N/A	Landing X Slope (%)	N/A	N/A	DWS	Full Width?
N/A	Landing Curb? (Y/N)	N/A	N/A	DWS	Offset (in)
N/A	Shared Landing?	N/A			
N/A	Gutter Ponding?	N/A	N/A	Gutte	er Slope (%)
N/A	Gutter Lip Ht (in)	N/A	N/A	Gutte	er X Slope (%)
N/A	Painted X Walk1?	No	N/A	Paint	ed X Walk2?
	X Walk 1 Direction	To E		X Wa	alk 2 Direction
N/A	X Walk 1 Width (in)	N/A	N/A	X Wa	alk 2 Width (in)
	X Walk 1 Slope (%)	5.1		X Wa	alk 2 Slope (%)
	X Walk 1 X Slope (%)	4.9		X Wa	alk 2 X Slope (%)
N/A	Ramp inside XWalk1?	N/A	N/A	Ram	p inside XWalk2?

Road Slope (%)	1.9	N/A	Clear	r Space?
	Road X Slope (%)	1.8	N/A	Clear	r Space to XWalk (in)
N/A	Any Obstructions?	N/A	N/A	Storn	n Grate/Utility Hazard?
	Obstruction Type			Storn	n Grate/Utility Type
		N/A

Remove & Replace Curb Ramp With Two New Directional Ramps or Equivalent.
