Access Compliance Report

Public Rights-of-Way

(Curb Ramps)

Intersection ID: 10040553		Main Street: W_7TH_ST		Cross Street: N/A		Location: E							
ADA ID: A1E809F49159		Ramp Type: Directional2		Initial Pass/Fail: Fail		Overall Compliance: No		Severity Score: 12.5					
Codes/Mitigation Info/Possible Solution				Field Measurements/Component Compliance

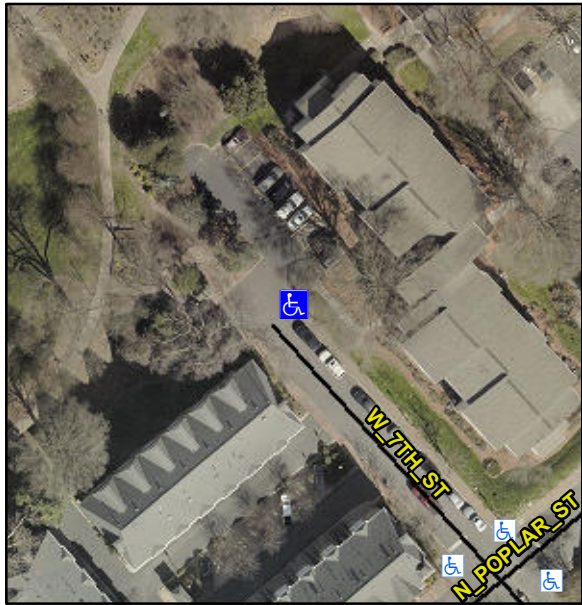
Possible Solutions:		Compliance		Description		Data			
				Remove & Replace Entire Ramp.		N/A	Ramp Length (in)	53.0		N/A	Grade Break?	N/A	
						Yes	Ramp Width (in)	58.0		N/A	Grade Break Slope (%)	0.0	
						Yes	Ramp Slope (%)	6.0		N/A	Grade Break XSlope (%)	0.0	
						No	Ramp XSlope (%)	6.6					
						N/A	Flare Type LT	N/A		N/A	Flare Type RT	N/A	
						N/A	Flare Slope LT (%)	N/A		N/A	Flare Slope RT (%)	0.0	
				Surveyor Notes:		N/A	Flare Traversable LT?	N/A		N/A	Flare Traversable RT?	N/A	
						N/A	Landing Length (in)	0.0		N/A	DWS Provided?	N/A	
						N/A	Landing Width (in)	0.0		N/A	DWS Contrast?	N/A

N/A	Landing Slope (%)	0.0		N/A	DWS Length (in)	N/A			
				N/A	Landing X Slope (%)	0.0		N/A	DWS Full Width?	N/A			
				N/A	Landing Curb? (Y/N)	N/A		N/A	DWS Offset LT (in)	N/A			
				N/A	Shared Landing?	N/A		N/A	DWS Offset RT (in)	N/A			
				N/A	Gutter Ponding?	0.0		N/A	Gutter Slope (%)	N/A			
				N/A	Gutter Lip Ht (in)	0.0		N/A	Gutter X Slope (%)	N/A			
				N/A	Painted X Walk1?	No			Road Slope (%)	2.4			
					X Walk 1 Direction	To NW			Road X Slope (%)	0.3			
					X Walk 1 Width (in)	N/A			Clear Space?	N/A			
					X Walk 1 Slope (%)	2.4		N/A	Clear Space to XWalk (in)	N/A			
					X Walk 1 X Slope (%)	0.3		N/A	Storm Grate/Utility Hazard?	N/A			
				N/A	Ramp inside XWalk1?	N/A			Storm Grate/Utility Type				
				N/A	Any Obstructions?	N/A				N/A			
					Obstruction Type			Yes	Surface Condition? (G/P)	Good			
								N/A	Curb Slope (%)	13.0			
				Street 1 Name		W 7TH ST							
				Stop Condition-Street 1		None
