Access Compliance Report

Public Rights-of-Way

(Curb Ramps)

Intersection ID: 15217	Main Street: ALBEMARLE_RD	Cross Street: WINTERHAVEN_DR	Location: SW
ADA ID: A1E943BCE8BE	Ramp Type: Perp	Initial Pass/Fail: Fail	Overall Compliance: No
Severity Score: 8.75			
Codes/Mitigation Info/Possible Solution		Field Measurements/Component Compliance

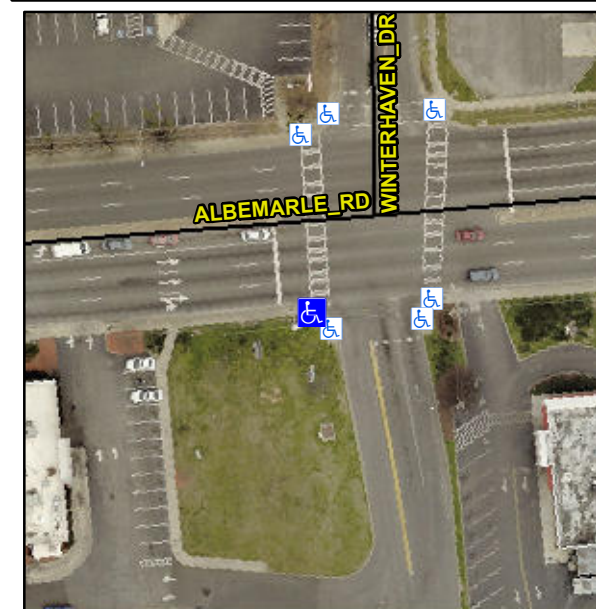
Not Found, R304.5.1

Compliance	Description	Data	Compliance	Description	Data
N/A	Ramp Length (in)	62.0	Yes	Ramp Slope (%)	6.0
No	Ramp Width (in)	40.0	Yes	Ramp XSlope (%)	0.3
N/A	Flare Type LT	N/A	N/A	Flare Type RT	N/A
N/A	Flare Slope LT (%)	N/A	N/A	Flare Slope RT (%)	N/A
N/A	Flare Traversable LT?	N/A	N/A	Flare Traversable RT?	N/A
N/A	Landing Length (in)	N/A	N/A	DWS Provided?	N/A
N/A	Landing Width (in)	N/A	N/A	DWS Contrast?	N/A
N/A	Landing Slope (%)	N/A	N/A	DWS Length (in)	N/A
N/A	Landing X Slope (%)	N/A	N/A	DWS Full Width?	N/A
N/A	Landing Curb? (Y/N)	N/A	N/A	DWS Offset (in)	N/A
N/A	Shared Landing?	N/A			
N/A	Gutter Ponding?	N/A	N/A	Gutter Slope (%)	N/A
N/A	Gutter Lip Ht (in)	N/A	N/A	Gutter X Slope (%)	N/A
N/A	Painted X Walk1?	Yes	N/A	Painted X Walk2?	N/A
	X Walk 1 Direction	To N		X Walk 2 Direction	N/A
N/A	X Walk 1 Width (in)	103.0	N/A	X Walk 2 Width (in)	N/A
	X Walk 1 Slope (%)	2.3		X Walk 2 Slope (%)	N/A
	X Walk 1 X Slope (%)	1.5		X Walk 2 X Slope (%)	N/A

N/A	Ramp inside XWalk1?	Yes	N/A	Ramp inside XWalk2?	N/A
	Road Slope (%)	N/A	N/A	Clear Space?	N/A
	Road X Slope (%)	N/A	N/A	Clear Space to XWalk (in)	N/A
N/A	Any Obstructions?	N/A	N/A	Storm Grate/Utility Hazard?	N/A
	Obstruction Type			Storm Grate/Utility Type	
		N/A			N/A
		Yes		Surface Condition? (G/P)	Good

Remove & Replace Entire Ramp.

Total Cost: \$ 1850.00
