# Access Compliance Report

## Public Rights-of-Way

### (Curb Ramps)

Intersection ID: 19935	Main Street: MORRISON_BV	Cross Street: ADAIR_CT	Location: NE
ADA ID: A1F19048AE3B	Ramp Type: ParaDiag	Initial Pass/Fail: Fail	Overall Compliance: No
Codes/Mitigation Info/Possible Solution			Severity Score: 50
			Field Measurements/Component Compliance

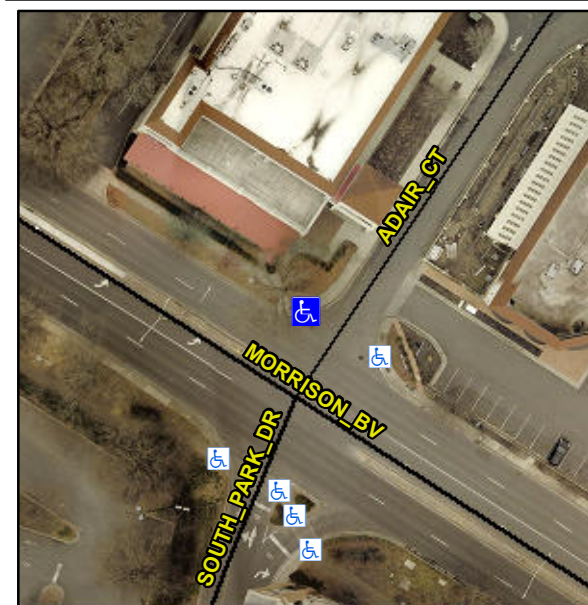
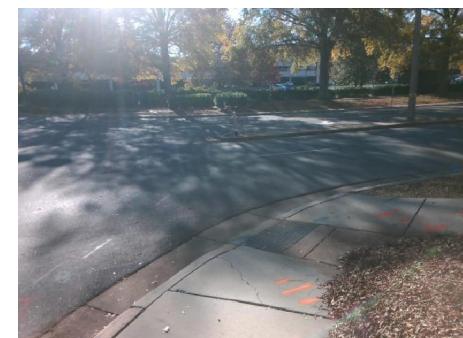
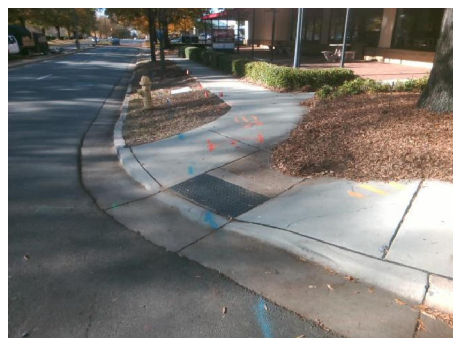
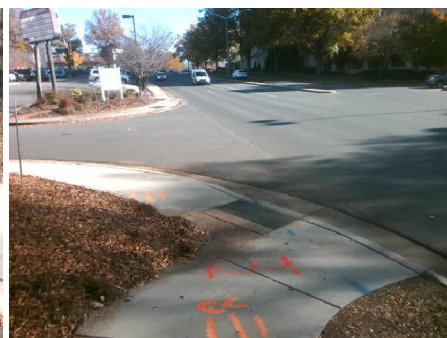
**LT RP < 5%**

**R304.5.3, R304.3.2**

Compliance	Description	Data	Compliance	Description	Data
N/A	Ramp Length LT (in)	64.0	N/A	Ramp Length RT (in)	51.0
Yes	Ramp Width LT (in)	54.0	Yes	Ramp Width RT (in)	67.0
Yes	Ramp Slope LT (%)	4.9	No	Ramp Slope RT (%)	16.1
No	Ramp XSlope LT (%)	14.9	No	Ramp XSlope RT (%)	7.3
N/A	Landing Length (in)	N/A	N/A	DWS Provided?	N/A
N/A	Landing Width (in)	N/A	N/A	DWS Contrast?	N/A
N/A	Landing Slope (%)	N/A	N/A	DWS Length (in)	N/A
N/A	Landing X Slope (%)	N/A	N/A	DWS Full Width?	N/A
N/A	Landing Curb? (Y/N)	N/A	N/A	DWS Offset (in)	N/A
N/A	Shared Landing?	N/A			
N/A	Gutter Ponding?	N/A	N/A	Gutter Slope (%)	N/A
N/A	Gutter Lip Ht (in)	N/A	N/A	Gutter X Slope (%)	N/A
N/A	Painted X Walk1?	No	N/A	Painted X Walk2?	No
	X Walk 1 Direction	To SW		X Walk 2 Direction	To SE
N/A	X Walk 1 Width (in)	N/A	N/A	X Walk 2 Width (in)	N/A
	X Walk 1 Slope (%)	0.9		X Walk 2 Slope (%)	0.9
	X Walk 1 X Slope (%)	3.7		X Walk 2 X Slope (%)	1.9
N/A	Ramp inside XWalk1?	N/A	N/A	Ramp inside XWalk2?	N/A

Road Slope (%)	3.8	N/A	Clear Space?	N/A
	Road X Slope (%)	0.2	N/A	Clear Space to XWalk (in)	N/A
N/A	Any Obstructions?	N/A	N/A	Storm Grate/Utility Hazard?	N/A
	Obstruction Type			Storm Grate/Utility Type	
		N/A			N/A
			Yes	Surface Condition? (G/P)	Good
			N/A	Curb Slope (%)	5.4

**Remove & Replace Curb Ramp With Two New Directional Ramps or Equivalent.**

Total Cost: \$ 3200.00
