# Access Compliance Report

## Public Rights-of-Way

| Intersection ID: 10077 | Main Street: E_35TH_ST | Cross Street: N_DAVIDSON_ST | Location: SW |
| ADA ID: A1F69E2AC3F5 | Ramp Type: BlendTrans2 | Initial Pass/Fail: Pass | Overall Compliance: No |

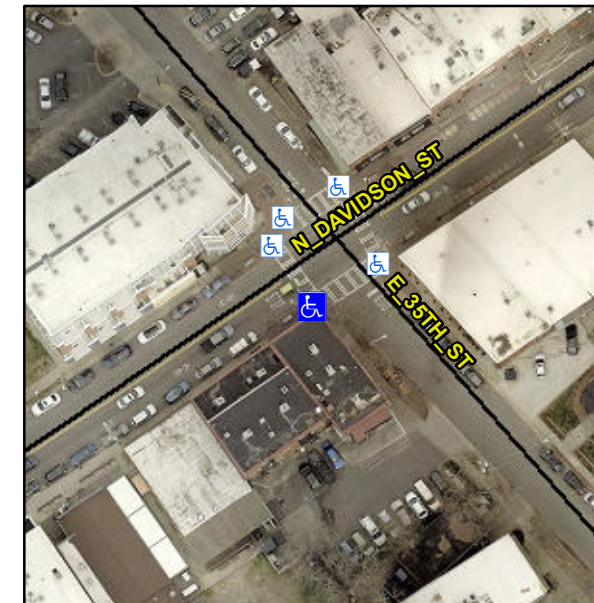
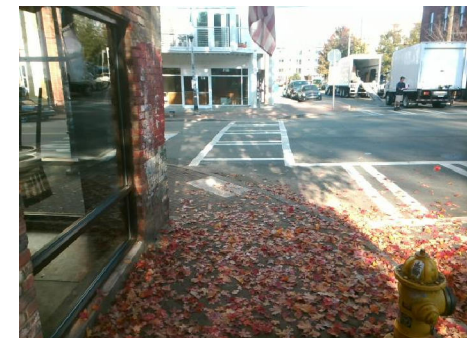
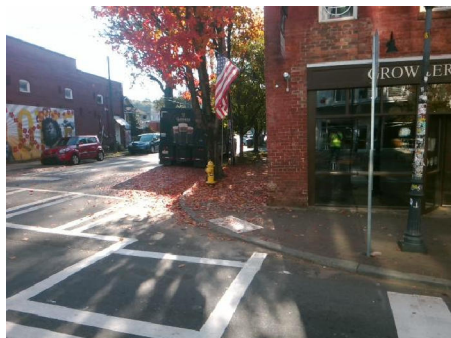
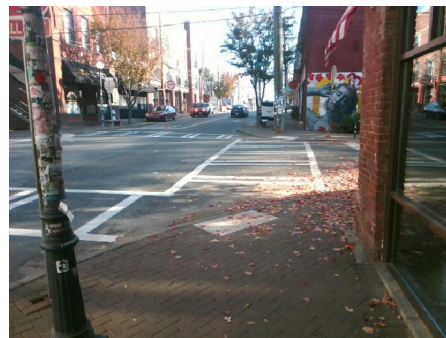
| | | Severity Score: 20 | |

| Compliance | Description | Data | Compliance | Description | Data |
|---|---|---|---|---|---|
| No | Flare Slope LT (%) | N/A | No | Flare Slope RT (%) | N/A |
| Yes | Gutter Ponding? | No | No | Gutter Slope (%) | 6.9 |
| No | Gutter Lip Ht (in) | 1.0 | Yes | Gutter X Slope (%) | 0.9 |

**Remove & Replace Curb Ramp With Two New Directional Ramps or Equivalent. Remove & Replace Gutter.**

**R304.2.3, R302.7.2, R304.5.4**

Total Cost: \$ 3950.00
