# Access Compliance Report

## Public Rights-of-Way

### (Curb Ramps)

Intersection ID: 4865	Main Street: HENDERSON_CR	Cross Street: CRYSTAL_CREST_WY	Location: NW
ADA ID: A1FE42ABD7B1	Ramp Type: PerpDiag	Initial Pass/Fail: Fail	Overall Compliance: No
Codes/Mitigation Info/Possible Solution		Field Measurements/Component Compliance	
Severity Score: 26.25

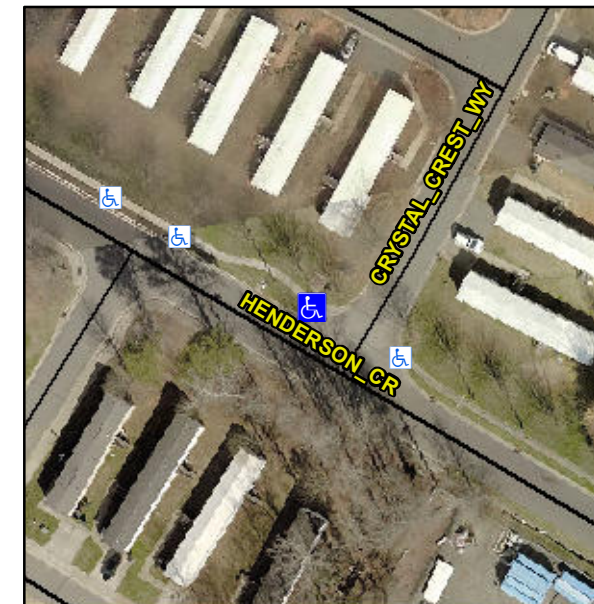
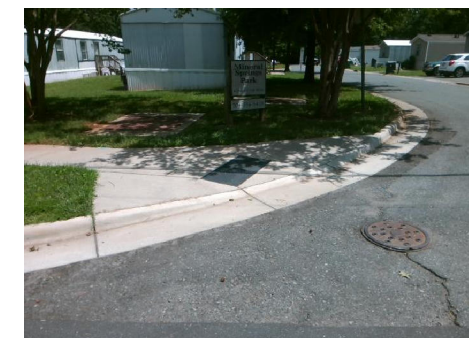
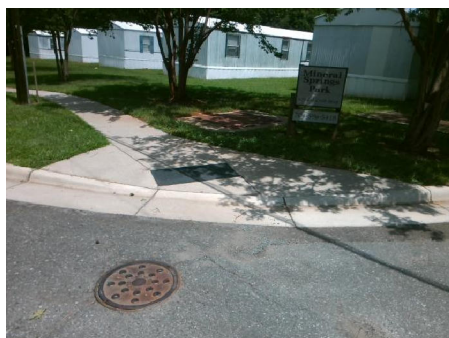
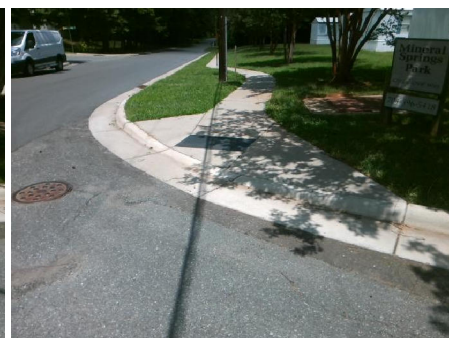
**Not Found, R304.2.2, R304.5.3**

Compliance	Description	Data	Compliance	Description	Data
N/A	Ramp Length (in)	62.0	No	Ramp Slope (%)	14.0
Yes	Ramp Width (in)	48.0	No	Ramp XSlope (%)	3.9
N/A	Flare Type LT	N/A	N/A	Flare Type RT	N/A
N/A	Flare Slope LT (%)	N/A	N/A	Flare Slope RT (%)	N/A
N/A	Flare Traversable LT?	N/A	N/A	Flare Traversable RT?	N/A
N/A	Landing Length (in)	N/A	N/A	DWS Provided?	N/A
N/A	Landing Width (in)	N/A	N/A	DWS Contrast?	N/A
N/A	Landing Slope (%)	N/A	N/A	DWS Length (in)	N/A
N/A	Landing X Slope (%)	N/A	N/A	DWS Full Width?	N/A
N/A	Landing Curb? (Y/N)	N/A	N/A	DWS Offset (in)	N/A
N/A	Shared Landing?	N/A			
N/A	Gutter Ponding?	N/A	N/A	Gutter Slope (%)	N/A
N/A	Gutter Lip Ht (in)	N/A	N/A	Gutter X Slope (%)	N/A
N/A	Painted X Walk1?	No	N/A	Painted X Walk2?	No
	X Walk 1 Direction	To SW		X Walk 2 Direction	To SE
N/A	X Walk 1 Width (in)	N/A	N/A	X Walk 2 Width (in)	N/A
	X Walk 1 Slope (%)	0.2		X Walk 2 Slope (%)	6.2
	X Walk 1 X Slope (%)	4.6		X Walk 2 X Slope (%)	0.5

N/A	Ramp inside XWalk1?	N/A	N/A	Ramp inside XWalk2?	N/A
	Road Slope (%)	1.2	N/A	Clear Space?	N/A
	Road X Slope (%)	4.2	N/A	Clear Space to XWalk (in)	N/A
N/A	Any Obstructions?	N/A	N/A	Storm Grate/Utility Hazard?	N/A
	Obstruction Type			Storm Grate/Utility Type	
		N/A			N/A
			Yes	Surface Condition? (G/P)	Good

**Remove & Replace Curb Ramp With Two New Directional Ramps or Equivalent.**
