Access Compliance Report

Public Rights-of-Way (Curb Ramps)

Intersection ID: 31723	Main Street: FILBERT_LN	Cross Street: GOLDENWILLOW_DR	Location: SW
ADA ID: A205DE1E7D81	Ramp Type: Perp	Initial Pass/Fail: Fail	Overall Compliance: No
			Severity Score: 21.25

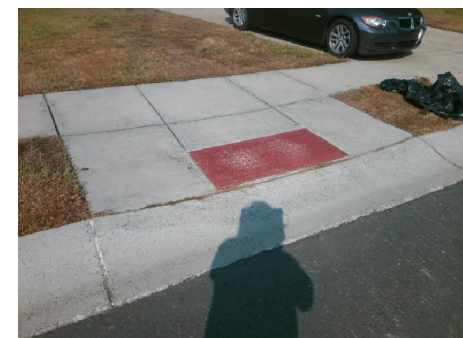
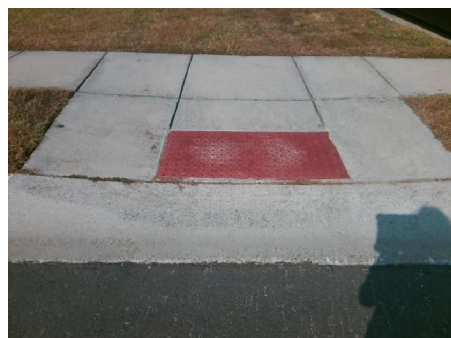
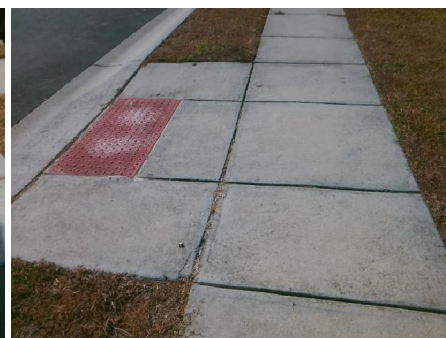
Not Found, R304.5.1, R304.5.3

Compliance	Description	Data	Compliance	Description	Data
N/A	Ramp Length (in)	48.0	Yes	Ramp Slope (%)	5.2
No	Ramp Width (in)	46.5	No	Ramp XSlope (%)	5.2
N/A	Flare Type LT	N/A	N/A	Flare Type RT	N/A
N/A	Flare Slope LT (%)	N/A	N/A	Flare Slope RT (%)	N/A
N/A	Flare Traversable LT?	N/A	N/A	Flare Traversable RT?	N/A
N/A	Landing Length (in)	N/A	N/A	DWS Provided?	N/A
N/A	Landing Width (in)	N/A	N/A	DWS Contrast?	N/A
N/A	Landing Slope (%)	N/A	N/A	DWS Length (in)	N/A
N/A	Landing X Slope (%)	N/A	N/A	DWS Full Width?	N/A
N/A	Landing Curb? (Y/N)	N/A	N/A	DWS Offset (in)	N/A
N/A	Shared Landing?	N/A			
N/A	Gutter Ponding?	N/A	N/A	Gutter Slope (%)	N/A
N/A	Gutter Lip Ht (in)	0.5	N/A	Gutter X Slope (%)	N/A
N/A	Painted X Walk1?	No	N/A	Painted X Walk2?	N/A
	X Walk 1 Direction	To NE		X Walk 2 Direction	N/A
N/A	X Walk 1 Width (in)	N/A	N/A	X Walk 2 Width (in)	N/A
	X Walk 1 Slope (%)	4.3		X Walk 2 Slope (%)	N/A
	X Walk 1 X Slope (%)	5.6		X Walk 2 X Slope (%)	N/A

Remove & Replace Entire Ramp.
