Access Compliance Report

Public Rights-of-Way

(Curb Ramps)

Intersection ID: 3474	Main Street: W_W_T_HARRIS_BV	Cross Street: W_WT_HARRIS_TO_I-77_RA_NB	Location: W
ADA ID: A207F3E04011	Ramp Type: Perp	Initial Pass/Fail: Fail	Overall Compliance: No
Severity Score: 22.5			
Codes/Mitigation Info/Possible Solution		Field Measurements/Component Compliance

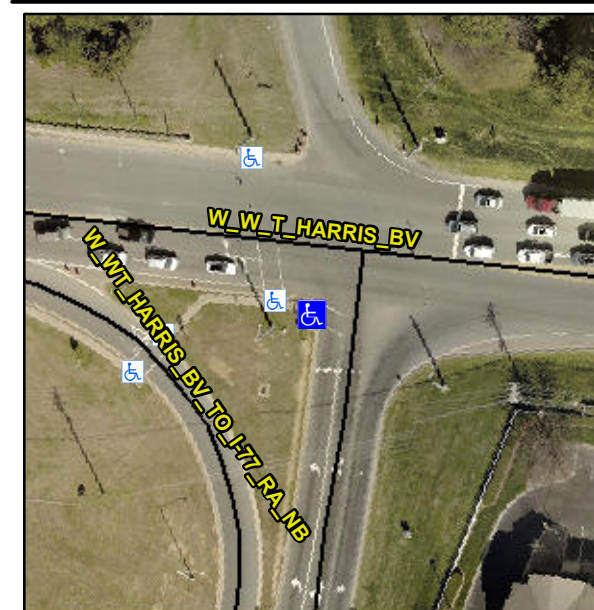
Compliance	Description	Data	Compliance	Description	Data
N/A	Ramp Length (in)	59.5	No	Ramp Slope (%)	9.9
No	Ramp Width (in)	41.0	No	Ramp XSlope (%)	2.7
N/A	Flare Type LT	N/A	N/A	Flare Type RT	N/A
N/A	Flare Slope LT (%)	N/A	N/A	Flare Slope RT (%)	N/A
N/A	Flare Traversable LT?	N/A	N/A	Flare Traversable RT?	N/A
N/A	Landing Length (in)	N/A	N/A	DWS Provided?	N/A
N/A	Landing Width (in)	N/A	N/A	DWS Contrast?	N/A
N/A	Landing Slope (%)	N/A	N/A	DWS Length (in)	N/A
N/A	Landing X Slope (%)	N/A	N/A	DWS Full Width?	N/A
N/A	Landing Curb? (Y/N)	N/A	N/A	DWS Offset (in)	N/A
N/A	Shared Landing?	N/A			
N/A	Gutter Ponding?	N/A	N/A	Gutter Slope (%)	N/A
N/A	Gutter Lip Ht (in)	N/A	N/A	Gutter X Slope (%)	N/A
N/A	Painted X Walk1?	No	N/A	Painted X Walk2?	N/A
	X Walk 1 Direction	To SE		X Walk 2 Direction	N/A
N/A	X Walk 1 Width (in)	N/A	N/A	X Walk 2 Width (in)	N/A
	X Walk 1 Slope (%)	1.8		X Walk 2 Slope (%)	N/A
	X Walk 1 X Slope (%)	1.9		X Walk 2 X Slope (%)	N/A

N/A	Ramp inside XWalk1?	N/A	N/A	Ramp inside XWalk2?	N/A
	Road Slope (%)	N/A	N/A	Clear Space?	N/A
	Road X Slope (%)	N/A	N/A	Clear Space to XWalk (in)	N/A
N/A	Any Obstructions?	N/A	N/A	Storm Grate/Utility Hazard?	N/A
	Obstruction Type			Storm Grate/Utility Type	
		N/A			N/A
			Yes	Surface Condition? (G/P)	Good

Possible Solutions:

Remove & Replace Entire Ramp.
