# Access Compliance Report

## Public Rights-of-Way

### (Curb Ramps)

| Intersection ID: 14326 | Main Street: BALDWIN_AV | Cross Street: LUTHER_ST | Location: SE |

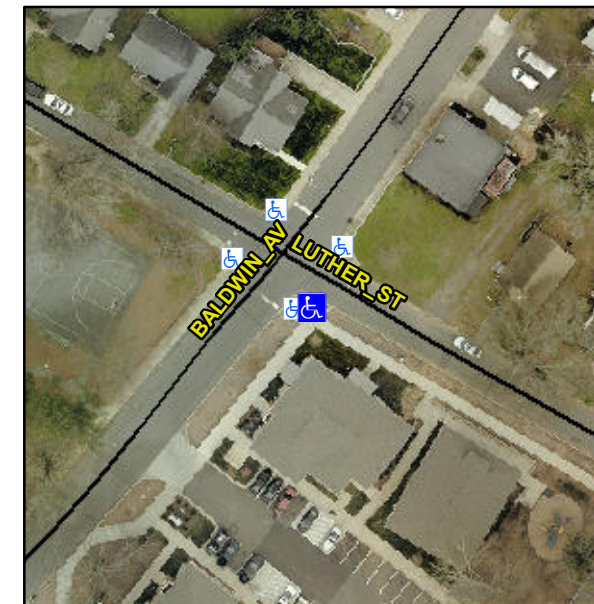
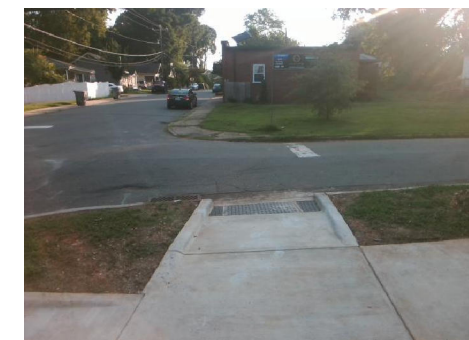
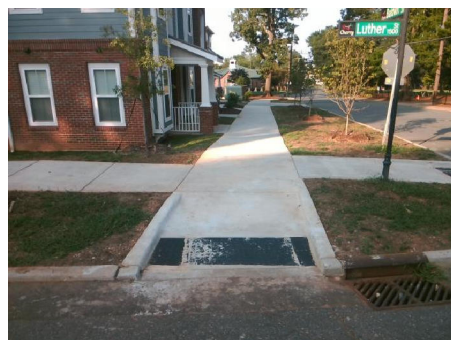
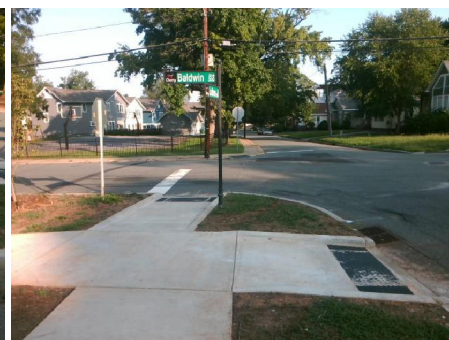
| ADA ID: A20A11305FB1 | Ramp Type: Perp | Initial Pass/Fail: Fail | Overall Compliance: No |
| Severity Score: 1.25 | | | |

| Compliance | Description | Data | Compliance | Description | Data |
|---|---|---|---|---|---|
| Yes | Ramp Width (in) | 68.0 | No | Ramp XSlope (%) | 3.5 |

**Remove & Replace Entire Ramp.**

**R304.5.3**

**\$ 1850.00**
