Access Compliance Report

Public Rights-of-Way

(Curb Ramps)

Intersection ID: 1003360	Main Street: HEATHCOTT_CR	Cross Street: N/A	Location: NE
ADA ID: A20EA3CB29B1	Ramp Type: Perp	Initial Pass/Fail: Fail	Overall Compliance: No
Codes/Mitigation Info/Possible Solution		Field Measurements/Component Compliance

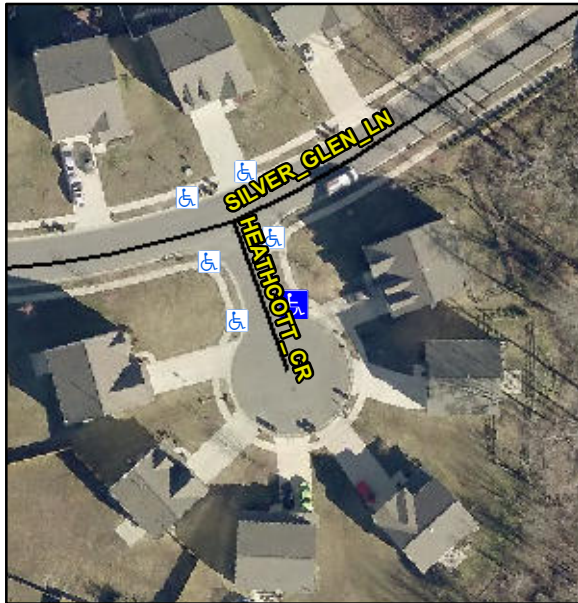
Not Found, R304.5.1

Compliance	Description	Data	Compliance	Description	Data
N/A	Ramp Length (in)	48.0	Yes	Ramp Slope (%)	7.3
No	Ramp Width (in)	47.0	Yes	Ramp XSlope (%)	2.9
N/A	Flare Type LT	N/A	N/A	Flare Type RT	N/A
N/A	Flare Slope LT (%)	N/A	N/A	Flare Slope RT (%)	N/A
N/A	Flare Traversable LT?	N/A	N/A	Flare Traversable RT?	N/A
N/A	Landing Length (in)	N/A	N/A	DWS Provided?	N/A
N/A	Landing Width (in)	N/A	N/A	DWS Contrast?	N/A
N/A	Landing Slope (%)	N/A	N/A	DWS Length (in)	N/A
N/A	Landing X Slope (%)	N/A	N/A	DWS Full Width?	N/A
N/A	Landing Curb? (Y/N)	N/A	N/A	DWS Offset (in)	N/A
N/A	Shared Landing?	N/A			
N/A	Gutter Ponding?	N/A	N/A	Gutter Slope (%)	N/A
N/A	Gutter Lip Ht (in)	N/A	N/A	Gutter X Slope (%)	N/A
N/A	Painted X Walk1?	No	N/A	Painted X Walk2?	N/A
	X Walk 1 Direction	To W		X Walk 2 Direction	N/A
N/A	X Walk 1 Width (in)	N/A	N/A	X Walk 2 Width (in)	N/A
	X Walk 1 Slope (%)	2.1		X Walk 2 Slope (%)	N/A
	X Walk 1 X Slope (%)	3.5		X Walk 2 X Slope (%)	N/A

N/A	Ramp inside XWalk1?	N/A	N/A	Ramp inside XWalk2?	N/A
	Road Slope (%)	N/A	N/A	Clear Space?	N/A
	Road X Slope (%)	N/A	N/A	Clear Space to XWalk (in)	N/A
N/A	Any Obstructions?	N/A	N/A	Storm Grate/Utility Hazard?	N/A
	Obstruction Type			Storm Grate/Utility Type	
		N/A			N/A
			Yes	Surface Condition? (G/P)	Good

Possible Solutions:

Remove & Replace Entire Ramp.
