Access Compliance Report

Public Rights-of-Way

(Curb Ramps)

Intersection ID: 10041624	Main Street: WHITEHALL_EXECUTIVE_CENTER_DR	Cross Street: N/A	Location: SE
ADA ID: A217DBB6CCB8	Ramp Type: Perp	Initial Pass/Fail: Fail	Overall Compliance: No
Severity Score: 17.5			
Codes/Mitigation Info/Possible Solution		Field Measurements/Component Compliance

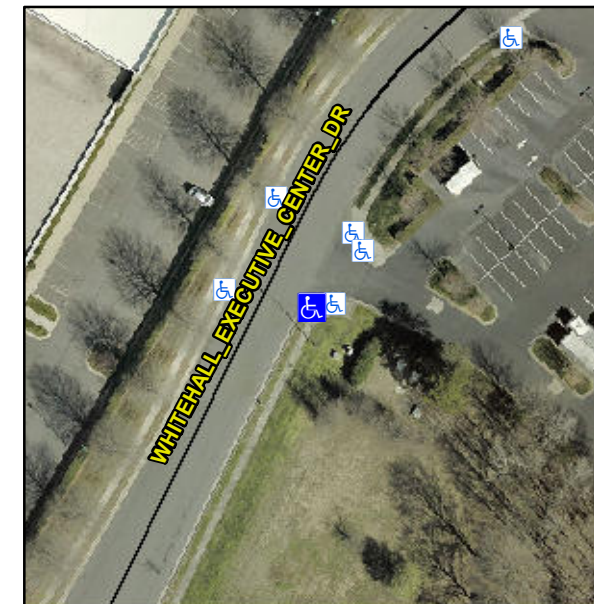
Not Found, R304.5.1

Compliance	Description	Data	Compliance	Description	Data
N/A	Ramp Length (in)	84.0	Yes	Ramp Slope (%)	6.4
No	Ramp Width (in)	33.0	Yes	Ramp XSlope (%)	0.9
N/A	Flare Type LT	N/A	N/A	Flare Type RT	N/A
N/A	Flare Slope LT (%)	N/A	N/A	Flare Slope RT (%)	N/A
N/A	Flare Traversable LT?	N/A	N/A	Flare Traversable RT?	N/A
N/A	Landing Length (in)	N/A	N/A	DWS Provided?	N/A
N/A	Landing Width (in)	N/A	N/A	DWS Contrast?	N/A
N/A	Landing Slope (%)	N/A	N/A	DWS Length (in)	N/A
N/A	Landing X Slope (%)	N/A	N/A	DWS Full Width?	N/A
N/A	Landing Curb? (Y/N)	N/A	N/A	DWS Offset (in)	N/A
N/A	Shared Landing?	N/A			
N/A	Gutter Ponding?	N/A	N/A	Gutter Slope (%)	N/A
N/A	Gutter Lip Ht (in)	N/A	N/A	Gutter X Slope (%)	N/A
N/A	Painted X Walk1?	No	N/A	Painted X Walk2?	N/A
	X Walk 1 Direction	To NW		X Walk 2 Direction	N/A
N/A	X Walk 1 Width (in)	N/A	N/A	X Walk 2 Width (in)	N/A
	X Walk 1 Slope (%)	4.5		X Walk 2 Slope (%)	N/A
	X Walk 1 X Slope (%)	2.4		X Walk 2 X Slope (%)	N/A

N/A	Ramp inside XWalk1?	N/A	N/A	Ramp inside XWalk2?	N/A
	Road Slope (%)	N/A	N/A	Clear Space?	N/A
	Road X Slope (%)	N/A	N/A	Clear Space to XWalk (in)	N/A
N/A	Any Obstructions?	N/A	N/A	Storm Grate/Utility Hazard?	N/A
	Obstruction Type			Storm Grate/Utility Type	
		N/A			N/A
			Yes	Surface Condition? (G/P)	Good

Possible Solutions:

Remove & Replace Entire Ramp.

Total Cost: \$ 1850.00
