Access Compliance Report

Public Rights-of-Way

(Curb Ramps)

Intersection ID: 15195	Main Street: ALBEMARLE_RD	Cross Street: FARM_POND_LN	Location:	N
ADA ID: A21B533D8C1B	Ramp Type: MedianPerp	Initial Pass/Fail: Fail	Overall Compliance: No	Severity Score: 8.75
Codes/Mitigation Info/Possible Solution		Field Measurements/Component Compliance

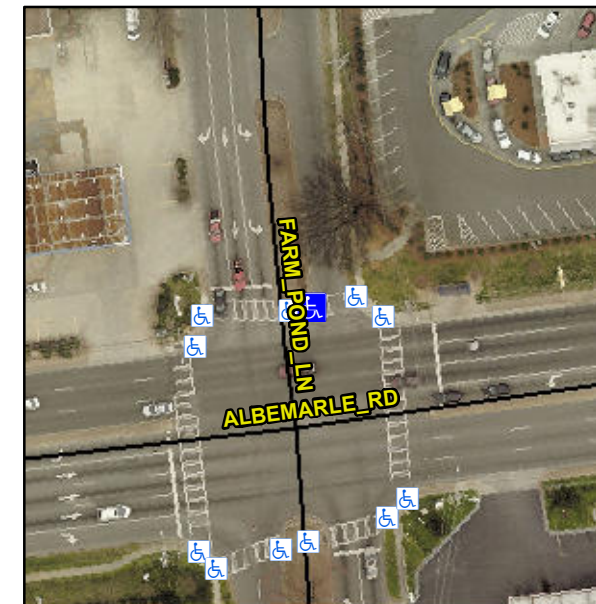
Not Found, R304.5.1

Compliance	Description	Data	Compliance	Description	Data
N/A	Ramp Length (in)	53.0	Yes	Ramp Slope (%)	6.4
No	Ramp Width (in)	41.0	Yes	Ramp XSlope (%)	1.8
N/A	Flare Type LT	N/A	N/A	Flare Type RT	N/A
N/A	Flare Slope LT (%)	N/A	N/A	Flare Slope RT (%)	N/A
N/A	Flare Traversable LT?	N/A	N/A	Flare Traversable RT?	N/A
N/A	Landing Length (in)	N/A	N/A	DWS Provided?	N/A
N/A	Landing Width (in)	N/A	N/A	DWS Contrast?	N/A
N/A	Landing Slope (%)	N/A	N/A	DWS Length (in)	N/A
N/A	Landing X Slope (%)	N/A	N/A	DWS Full Width?	N/A
N/A	Landing Curb? (Y/N)	N/A	N/A	DWS Offset (in)	N/A
N/A	Shared Landing?	N/A			
N/A	Gutter Ponding?	N/A	N/A	Gutter Slope (%)	N/A
N/A	Gutter Lip Ht (in)	N/A	N/A	Gutter X Slope (%)	N/A
N/A	Painted X Walk1?	Yes	N/A	Painted X Walk2?	N/A
	X Walk 1 Direction	To E		X Walk 2 Direction	N/A
N/A	X Walk 1 Width (in)	110.0	N/A	X Walk 2 Width (in)	N/A
	X Walk 1 Slope (%)	2.5		X Walk 2 Slope (%)	N/A
	X Walk 1 X Slope (%)	2.0		X Walk 2 X Slope (%)	N/A

N/A	Ramp inside XWalk1?	Yes	N/A	Ramp inside XWalk2?	N/A
	Road Slope (%)	N/A	N/A	Clear Space?	N/A
	Road X Slope (%)	N/A	N/A	Clear Space to XWalk (in)	N/A
N/A	Any Obstructions?	N/A	N/A	Storm Grate/Utility Hazard?	N/A
	Obstruction Type			Storm Grate/Utility Type	
		N/A			N/A
			Yes	Surface Condition? (G/P)	Good

Remove & Replace Entire Ramp.
