Access Compliance Report

Public Rights-of-Way

(Curb Ramps)

Intersection ID: 10031405	Main Street: MCALPINE_PARK_DR	Cross Street: N/A	Location: NE
ADA ID: A21DC1CEDFF2	Ramp Type: PerpDiag	Initial Pass/Fail: Fail	Overall Compliance: No
Severity Score: 13.75			
Codes/Mitigation Info/Possible Solution		Field Measurements/Component Compliance

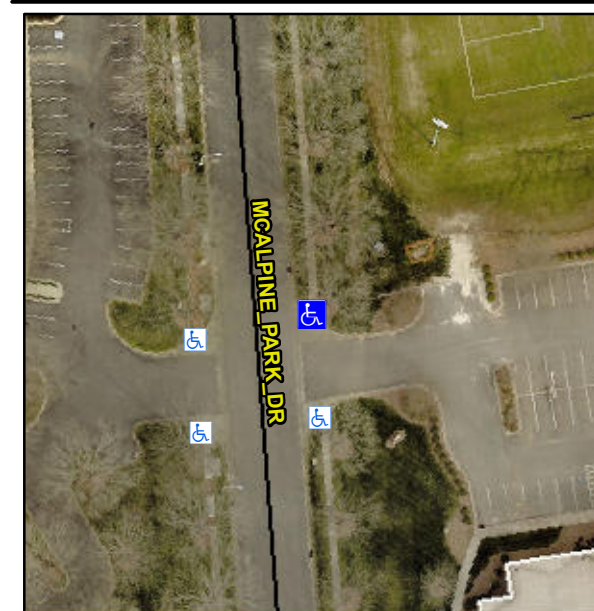
Not Found, R304.2.2, R304.5.3

Compliance	Description	Data	Compliance	Description	Data
N/A	Ramp Length (in)	59.5	No	Ramp Slope (%)	11.7
Yes	Ramp Width (in)	49.0	No	Ramp XSlope (%)	3.3
N/A	Flare Type LT	N/A	N/A	Flare Type RT	N/A
N/A	Flare Slope LT (%)	N/A	N/A	Flare Slope RT (%)	N/A
N/A	Flare Traversable LT?	N/A	N/A	Flare Traversable RT?	N/A
N/A	Landing Length (in)	N/A	N/A	DWS Provided?	N/A
N/A	Landing Width (in)	N/A	N/A	DWS Contrast?	N/A
N/A	Landing Slope (%)	N/A	N/A	DWS Length (in)	N/A
N/A	Landing X Slope (%)	N/A	N/A	DWS Full Width?	N/A
N/A	Landing Curb? (Y/N)	N/A	N/A	DWS Offset (in)	N/A
N/A	Shared Landing?	N/A			
N/A	Gutter Ponding?	N/A	N/A	Gutter Slope (%)	N/A
N/A	Gutter Lip Ht (in)	N/A	N/A	Gutter X Slope (%)	N/A
N/A	Painted X Walk1?	No	N/A	Painted X Walk2?	No
	X Walk 1 Direction	To W		X Walk 2 Direction	To S
N/A	X Walk 1 Width (in)	N/A	N/A	X Walk 2 Width (in)	N/A
	X Walk 1 Slope (%)	5.5		X Walk 2 Slope (%)	3.7
	X Walk 1 X Slope (%)	2.7		X Walk 2 X Slope (%)	1.4

N/A	Ramp inside XWalk1?	N/A	N/A	Ramp inside XWalk2?	N/A
	Road Slope (%)	1.2	N/A	Clear Space?	N/A
	Road X Slope (%)	3.9	N/A	Clear Space to XWalk (in)	N/A
N/A	Any Obstructions?	N/A	N/A	Storm Grate/Utility Hazard?	N/A
	Obstruction Type			Storm Grate/Utility Type	
		N/A			N/A
		Yes		Surface Condition? (G/P)	Good

Remove & Replace Curb Ramp With Two New Directional Ramps or Equivalent.
