# Access Compliance Report

## Public Rights-of-Way

### (Curb Ramps)

Intersection ID: N/A	Main Street: JOHN_BELK_RA	Cross Street: S_CALDWELL_ST	Location: SW
ADA ID: A226798B1927	Ramp Type: Perp	Initial Pass/Fail: Fail	Overall Compliance: No
		Severity Score: 25

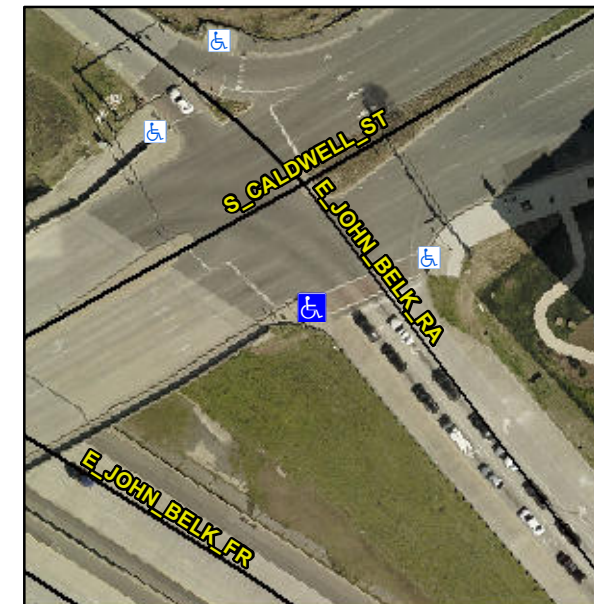
#### Field Measurements/Component Compliance

**Not Found, R304.2.2, R304.5.3**

Compliance	Description	Data	Compliance	Description	Data
N/A	Ramp Length (in)	94.0	No	Ramp Slope (%)	9.9
Yes	Ramp Width (in)	48.0	No	Ramp XSlope (%)	5.9
N/A	Flare Type LT	N/A	N/A	Flare Type RT	N/A
N/A	Flare Slope LT (%)	N/A	N/A	Flare Slope RT (%)	N/A
N/A	Flare Traversable LT?	No	N/A	Flare Traversable RT?	No
N/A	Landing Length (in)	N/A	N/A	DWS Provided?	N/A
N/A	Landing Width (in)	N/A	N/A	DWS Contrast?	N/A
N/A	Landing Slope (%)	N/A	N/A	DWS Length (in)	N/A
N/A	Landing X Slope (%)	N/A	N/A	DWS Full Width?	N/A
N/A	Landing Curb? (Y/N)	N/A	N/A	DWS Offset (in)	N/A
N/A	Shared Landing?	N/A			
N/A	Gutter Ponding?	N/A	N/A	Gutter Slope (%)	N/A
N/A	Gutter Lip Ht (in)	N/A	N/A	Gutter X Slope (%)	N/A
N/A	Painted X Walk1?	Yes	N/A	Painted X Walk2?	N/A
	X Walk 1 Direction	To E		X Walk 2 Direction	N/A
N/A	X Walk 1 Width (in)	127.0	N/A	X Walk 2 Width (in)	N/A
	X Walk 1 Slope (%)	2.9		X Walk 2 Slope (%)	N/A
	X Walk 1 X Slope (%)	1.2		X Walk 2 X Slope (%)	N/A

N/A	Ramp inside XWalk1?	Yes	N/A	Ramp inside XWalk2?	N/A
	Road Slope (%)	N/A	N/A	Clear Space?	N/A
	Road X Slope (%)	N/A	N/A	Clear Space to XWalk (in)	N/A
N/A	Any Obstructions?	N/A	N/A	Storm Grate/Utility Hazard?	N/A
	Obstruction Type			Storm Grate/Utility Type	
		N/A			N/A
			Yes	Surface Condition? (G/P)	Good

Possible Solutions:

**Remove & Replace Entire Ramp.**
