# Access Compliance Report

## Public Rights-of-Way

### (Curb Ramps)

| Intersection ID: 46147 | Main Street: ROCKY_FORD_CLUB_RD | Cross Street: ARBOR_CREEK_DR | Location: NE |

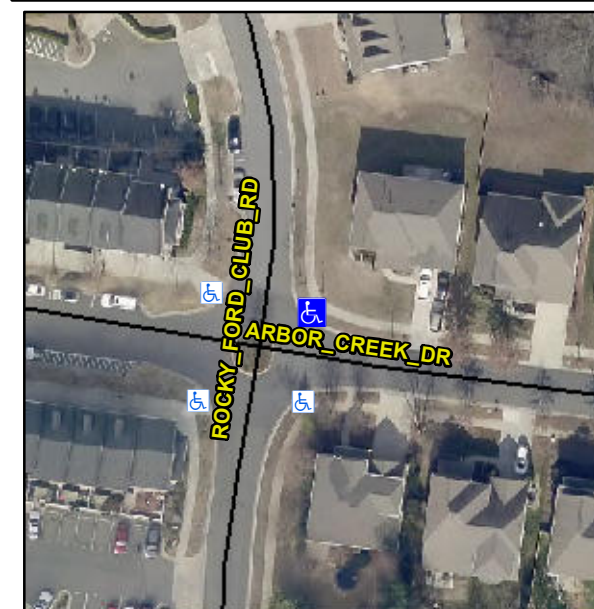
Surveyor Notes:

**CURB UNMODIFIED**

PROW/ADA:

**Not Found, R304.5.3**

| Compliance | Description | Data | Compliance | Description | Data |
|---|---|---|---|---|---|
| Yes | Ramp Width (in) | 48.0 | No | BlendTrans XSlope (%) | 4.3 |
| | | | No | Curb Slope (%) | 26.8 |

Possible Solutions:

**Remove & Replace Curb Ramp With Two New Directional Ramps or Equivalent.**

Total Cost: \$ 3200.00
