Access Compliance Report Public Rights-of-Way (Curb Ramps)

Intersection ID: 28642 Main Street: PADSTOW CT Cross Street: STEWARTS CROSSING DR Location: SW **Severity Score:** ADA ID: A23A5F14C1FB Ramp Type: PerpDiag Initial Pass/Fail: Fail **Overall Compliance: No** 16.25

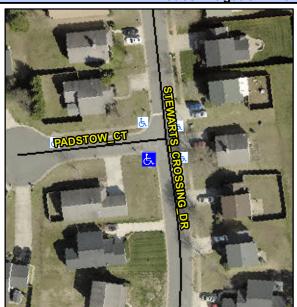
Total Cost: 3200.00 Compliance Description Data Compliance Description Data Yes N/A Ramp Length (in) 39.5 Ramp Slope (%) 6.9 No Ramp XSlope (%) Yes Ramp Width (in) 48.0 4.0 N/A Flare Type LT N/A N/A Flare Type RT N/A N/A N/A N/A Flare Slope RT (%) N/A Flare Slope LT (%) N/A Flare Traversable LT? N/A N/A Flare Traversable RT? N/A N/A N/A N/A **DWS Provided?** N/A Landing Length (in) N/A Landing Width (in) N/A N/A **DWS Contrast?** N/A N/A N/A N/A Landing Slope (%) DWS Length (in) N/A N/A Landing X Slope (%) N/A N/A DWS Full Width? N/A N/A Landing Curb? (Y/N) N/A N/A DWS Offset (in) N/A N/A N/A Shared Landing? N/A **Gutter Ponding?** N/A N/A Gutter Slope (%) N/A N/A Gutter Lip Ht (in) N/A N/A Gutter X Slope (%) N/A N/A Painted X Walk1? No N/A Painted X Walk2? No X Walk 1 Direction To E X Walk 2 Direction To N N/A N/A X Walk 1 Width (in) N/A X Walk 2 Width (in) N/A X Walk 1 Slope (%) 0.5 X Walk 2 Slope (%) 2.0 X Walk 1 X Slope (%) 2.4 X Walk 2 X Slope (%) 3.1 N/A N/A N/A Ramp inside XWalk2? N/A Ramp inside XWalk1? Road Slope (%) 1.6 N/A Clear Space? N/A N/A Road X Slope (%) 0.2 Clear Space to XWalk (in) N/A N/A N/A N/A Any Obstructions? Storm Grate/Utility Hazard? N/A **Obstruction Type** Storm Grate/Utility Type N/A N/A

Surface Condition? (G/P)

Poor

Possible Solutions: Remove & Replace Curb Ramp With Two New Directional Ramps or Equivalent. Surveyor Notes: N/A PROW/ADA: Not Found, R304.5.3, R302.7
