Access Compliance Report

Public Rights-of-Way

(Curb Ramps)

Intersection ID: 42535	Main Street: BALTINGLASS_CT	Cross Street: CASTLETOWN_HOUSE_DR	Location: SE
ADA ID: A243373344EC	Ramp Type: PerpDiag	Initial Pass/Fail: Fail	Overall Compliance: No
Codes/Mitigation Info/Possible Solution		Field Measurements/Component Compliance	
Severity Score: 33.75

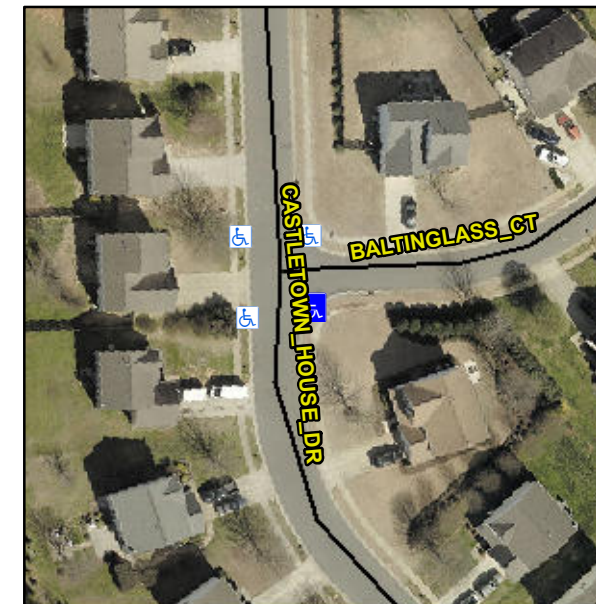
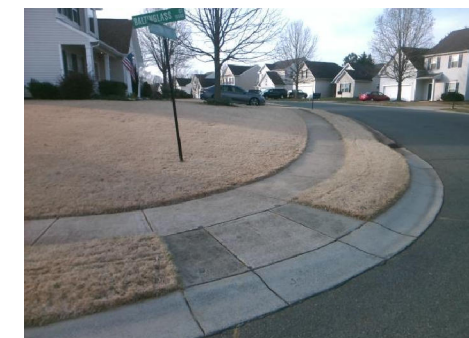
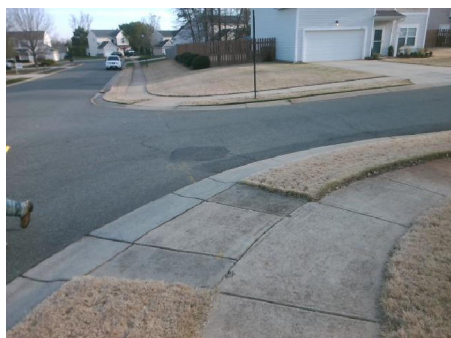
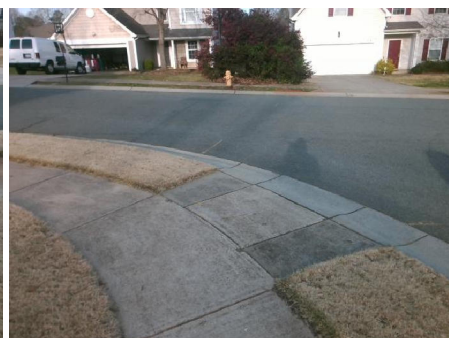
Not Found, R304.5.1, R304.2.2, R304.5.3

Compliance	Description	Data	Compliance	Description	Data
N/A	Ramp Length (in)	47.5	No	Ramp Slope (%)	8.7
No	Ramp Width (in)	40.5	No	Ramp XSlope (%)	5.1
N/A	Flare Type LT	N/A	N/A	Flare Type RT	N/A
N/A	Flare Slope LT (%)	N/A	N/A	Flare Slope RT (%)	N/A
N/A	Flare Traversable LT?	N/A	N/A	Flare Traversable RT?	N/A
N/A	Landing Length (in)	N/A	N/A	DWS Provided?	N/A
N/A	Landing Width (in)	N/A	N/A	DWS Contrast?	N/A
N/A	Landing Slope (%)	N/A	N/A	DWS Length (in)	N/A
N/A	Landing X Slope (%)	N/A	N/A	DWS Full Width?	N/A
N/A	Landing Curb? (Y/N)	N/A	N/A	DWS Offset (in)	N/A
N/A	Shared Landing?	N/A			
N/A	Gutter Ponding?	N/A	N/A	Gutter Slope (%)	N/A
N/A	Gutter Lip Ht (in)	N/A	N/A	Gutter X Slope (%)	N/A
N/A	Painted X Walk1?	No	N/A	Painted X Walk2?	No
	X Walk 1 Direction	To N		X Walk 2 Direction	To W
N/A	X Walk 1 Width (in)	N/A	N/A	X Walk 2 Width (in)	N/A
	X Walk 1 Slope (%)	2.9		X Walk 2 Slope (%)	1.2
	X Walk 1 X Slope (%)	2.2		X Walk 2 X Slope (%)	3.0

N/A	Ramp inside XWalk1?	N/A	N/A	Ramp inside XWalk2?	N/A
	Road Slope (%)	2.9	N/A	Clear Space?	N/A
	Road X Slope (%)	0.9	N/A	Clear Space to XWalk (in)	N/A
N/A	Any Obstructions?	N/A	N/A	Storm Grate/Utility Hazard?	N/A
	Obstruction Type			Storm Grate/Utility Type	
		N/A			N/A
			Yes	Surface Condition? (G/P)	Good

Remove & Replace Curb Ramp With Two New Directional Ramps or Equivalent.
