Access Compliance Report

Public Rights-of-Way

(Curb Ramps)

Intersection ID: 52448	Main Street: WOODWARD_AV	Cross Street: DOUBLE_OAKS_RD	Location: SE
ADA ID: A255C19597AB	Ramp Type: Directional1	Initial Pass/Fail: Fail	Overall Compliance: No
Severity Score: 13.75			
Codes/Mitigation Info/Possible Solution		Field Measurements/Component Compliance

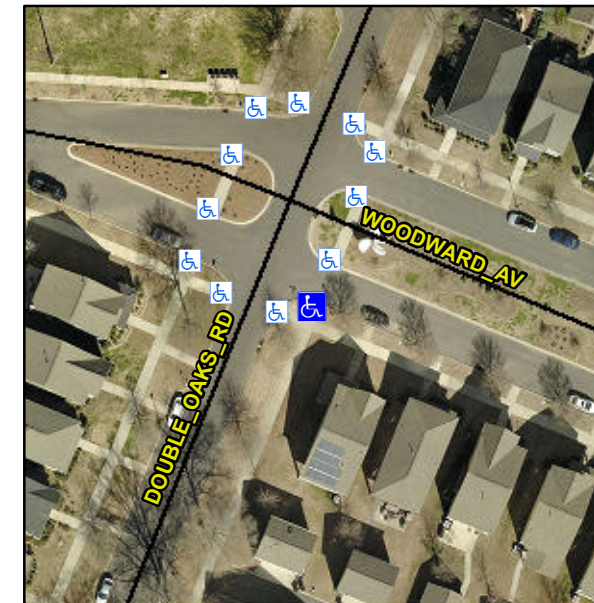
R304.2.2, R304.5.3

Compliance	Description	Data	Compliance	Description	Data
N/A	Ramp Length (in)	95.0	N/A	Grade Break?	N/A
Yes	Ramp Width (in)	69.0	N/A	Grade Break Slope (%)	0.0
No	Ramp Slope (%)	10.0	N/A	Grade Break XSlope (%)	0.0
No	Ramp XSlope (%)	2.2			
N/A	Flare Type LT	N/A	N/A	Flare Type RT	N/A
N/A	Flare Slope LT (%)	N/A	N/A	Flare Slope RT (%)	0.0
N/A	Flare Traversable LT?	N/A	N/A	Flare Traversable RT?	N/A
N/A	Landing Length (in)	0.0	N/A	DWS Provided?	N/A
N/A	Landing Width (in)	0.0	N/A	DWS Contrast?	N/A
N/A	Landing Slope (%)	0.0	N/A	DWS Length (in)	N/A
N/A	Landing X Slope (%)	0.0	N/A	DWS Full Width?	N/A
N/A	Landing Curb? (Y/N)	N/A	N/A	DWS Offset LT (in)	N/A
N/A	Shared Landing?	N/A	N/A	DWS Offset RT (in)	N/A
N/A	Gutter Ponding?	0.0	N/A	Gutter Slope (%)	N/A
N/A	Gutter Lip Ht (in)	1.0	N/A	Gutter X Slope (%)	N/A
N/A	Painted X Walk1?	No		Road Slope (%)	1.9
	X Walk 1 Direction	To N		Road X Slope (%)	3.2
	X Walk 1 Width (in)	N/A		Clear Space?	N/A

X Walk 1 Slope (%)	1.9	N/A	Clear Space to XWalk (in)	N/A
	X Walk 1 X Slope (%)	3.2	N/A	Storm Grate/Utility Hazard?	N/A
N/A	Ramp inside XWalk1?	N/A		Storm Grate/Utility Type	
N/A	Any Obstructions?	N/A			N/A
	Obstruction Type		Yes	Surface Condition? (G/P)	Good
			N/A	Curb Slope (%)	1.6

Remove & Replace Entire Ramp.
