Access Compliance Report

Public Rights-of-Way

(Curb Ramps)

| Intersection ID: 30502 | Main Street: ORCHARD_GRASS_CT | Cross Street: STONES_LANDING_ST | Location: SE |

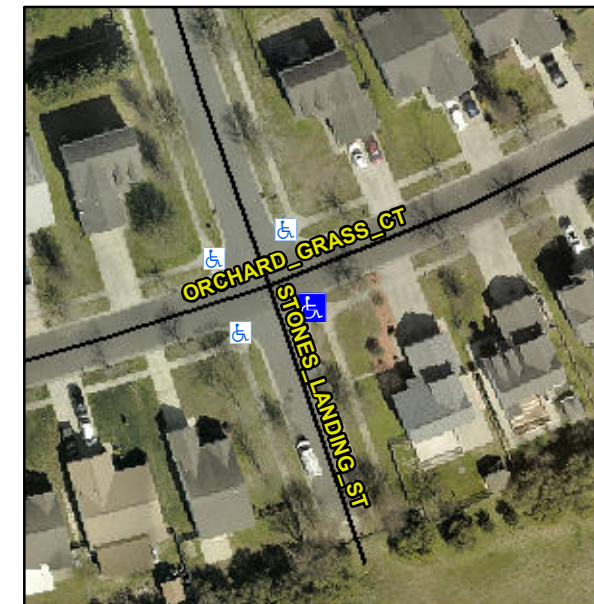
| ADA ID: A267CB9E4E36 | Ramp Type: PerpDiag | Initial Pass/Fail: Fail | Overall Compliance: No |
| Severity Score: 8.75 | | | |

Not Found, R304.5.1

| Compliance | Description | Data | Compliance | Description | Data |
|---|---|---|---|---|---|
| No | Ramp Width (in) | 38.0 | Yes | Ramp XSlope (%) | 1.4 |

Remove & Replace Curb Ramp With Two New Directional Ramps or Equivalent.
