Access Compliance Report

Public Rights-of-Way

(Curb Ramps)

Intersection ID: 3114	Main Street: BROWNESTONE_VIEW_DR	Cross Street: RIDGELINE_LN	Location:	N
ADA ID: A26AEC818141	Ramp Type: Perp	Initial Pass/Fail: Fail	Overall Compliance: No	Severity Score: 25
Codes/Mitigation Info/Possible Solution		Field Measurements/Component Compliance

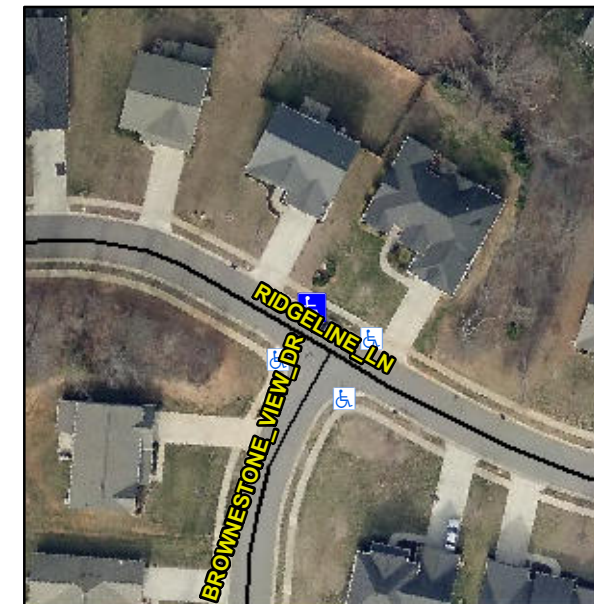
Not Found, R304.5.1, R304.5.3, R302.7

Compliance	Description	Data	Compliance	Description	Data
N/A	Ramp Length (in)	47.0	Yes	Ramp Slope (%)	6.0
No	Ramp Width (in)	47.5	No	Ramp XSlope (%)	2.4
N/A	Flare Type LT	N/A	N/A	Flare Type RT	N/A
N/A	Flare Slope LT (%)	N/A	N/A	Flare Slope RT (%)	N/A
N/A	Flare Traversable LT?	N/A	N/A	Flare Traversable RT?	N/A
N/A	Landing Length (in)	N/A	N/A	DWS Provided?	N/A
N/A	Landing Width (in)	N/A	N/A	DWS Contrast?	N/A
N/A	Landing Slope (%)	N/A	N/A	DWS Length (in)	N/A
N/A	Landing X Slope (%)	N/A	N/A	DWS Full Width?	N/A
N/A	Landing Curb? (Y/N)	N/A	N/A	DWS Offset (in)	N/A
N/A	Shared Landing?	N/A			
N/A	Gutter Ponding?	N/A	N/A	Gutter Slope (%)	N/A
N/A	Gutter Lip Ht (in)	N/A	N/A	Gutter X Slope (%)	N/A
N/A	Painted X Walk1?	No	N/A	Painted X Walk2?	N/A
	X Walk 1 Direction	To SW		X Walk 2 Direction	N/A
N/A	X Walk 1 Width (in)	N/A	N/A	X Walk 2 Width (in)	N/A
	X Walk 1 Slope (%)	1.9		X Walk 2 Slope (%)	N/A
	X Walk 1 X Slope (%)	0.7		X Walk 2 X Slope (%)	N/A

N/A	Ramp inside XWalk1?	N/A	N/A	Ramp inside XWalk2?	N/A
	Road Slope (%)	N/A	N/A	Clear Space?	N/A
	Road X Slope (%)	N/A	N/A	Clear Space to XWalk (in)	N/A
N/A	Any Obstructions?	N/A	N/A	Storm Grate/Utility Hazard?	N/A
	Obstruction Type			Storm Grate/Utility Type	
		N/A			N/A
		No		Surface Condition? (G/P)	Poor

Remove & Replace Entire Ramp.
