Access Compliance Report

Public Rights-of-Way

(Curb Ramps)

Intersection ID: 15323	Main Street: FANNIE_CR	Cross Street: GENE_AV	Location: N
ADA ID: A27BEF7F8689	Ramp Type: ParaDiag	Initial Pass/Fail: Fail	Overall Compliance: No
			Severity Score: 26.25

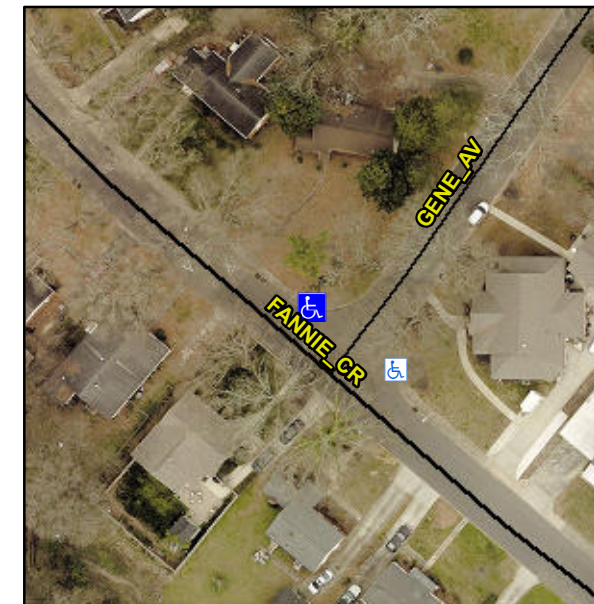
LT RP < 5%

Compliance	Description	Data	Compliance	Description	Data
N/A	Ramp Length LT (in)	58.0	N/A	Ramp Length RT (in)	66.0
Yes	Ramp Width LT (in)	60.0	Yes	Ramp Width RT (in)	60.0
Yes	Ramp Slope LT (%)	3.8	No	Ramp Slope RT (%)	17.5
No	Ramp XSlope LT (%)	2.4	No	Ramp XSlope RT (%)	3.9
N/A	Landing Length (in)	N/A	N/A	DWS Provided?	N/A
N/A	Landing Width (in)	N/A	N/A	DWS Contrast?	N/A
N/A	Landing Slope (%)	N/A	N/A	DWS Length (in)	N/A
N/A	Landing X Slope (%)	N/A	N/A	DWS Full Width?	N/A
N/A	Landing Curb? (Y/N)	N/A	N/A	DWS Offset (in)	N/A
N/A	Shared Landing?	N/A			
N/A	Gutter Ponding?	N/A	N/A	Gutter Slope (%)	N/A
N/A	Gutter Lip Ht (in)	N/A	N/A	Gutter X Slope (%)	N/A
N/A	Painted X Walk1?	No	N/A	Painted X Walk2?	No
	X Walk 1 Direction	To SW		X Walk 2 Direction	To SE
N/A	X Walk 1 Width (in)	N/A	N/A	X Walk 2 Width (in)	N/A
	X Walk 1 Slope (%)	1.1		X Walk 2 Slope (%)	4.1
	X Walk 1 X Slope (%)	3.5		X Walk 2 X Slope (%)	6.9
N/A	Ramp inside XWalk1?	N/A	N/A	Ramp inside XWalk2?	N/A

Road Slope (%)	4.9	N/A	Clear Space?	N/A
	Road X Slope (%)	0.5	N/A	Clear Space to XWalk (in)	N/A
N/A	Any Obstructions?	N/A	N/A	Storm Grate/Utility Hazard?	N/A
	Obstruction Type			Storm Grate/Utility Type	
		N/A			N/A
			Yes	Surface Condition? (G/P)	Good
			N/A	Curb Slope (%)	5.5

Remove & Replace Curb Ramp With Two New Directional Ramps or Equivalent.

R304.5.3, R304.3.2
