Access Compliance Report

Public Rights-of-Way

(Curb Ramps)

Intersection ID: 10037210	Main Street: SANDY_ROCK_PL	Cross Street: N/A	Location: E
ADA ID: A27E9F0C4C61	Ramp Type: Perp	Initial Pass/Fail: Pass	Overall Compliance: No
Severity Score: 2.5			
Codes/Mitigation Info/Possible Solution		Field Measurements/Component Compliance

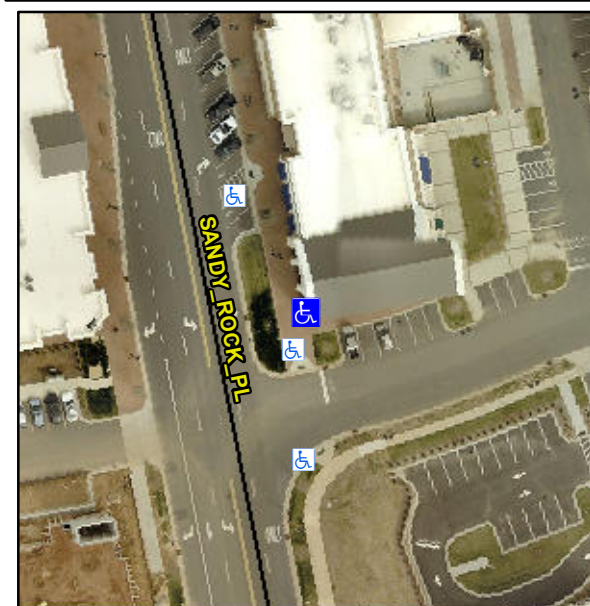
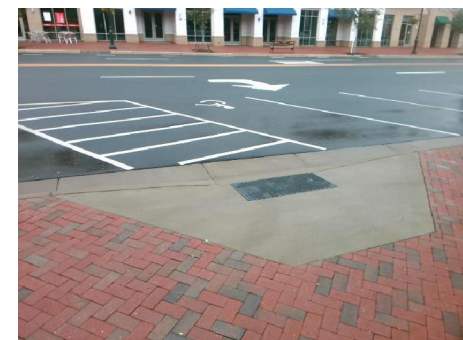
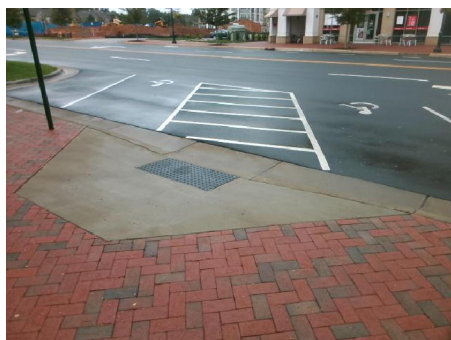
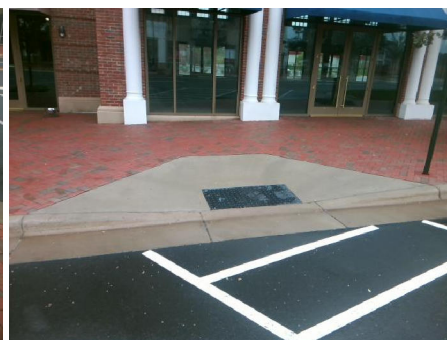
Not Found, R304.5.3, R304.2.3

Compliance	Description	Data	Compliance	Description	Data
N/A	Ramp Length (in)	77.0	Yes	Ramp Slope (%)	7.6
Yes	Ramp Width (in)	60.0	Yes	Ramp XSlope (%)	0.8
N/A	Flare Type LT	Sloped	N/A	Flare Type RT	N/A
N/A	Flare Slope LT (%)	6.7	No	Flare Slope RT (%)	10.1
N/A	Flare Traversable LT?	Yes	N/A	Flare Traversable RT?	Yes
Yes	Landing Length (in)	60.0	Yes	DWS Provided?	Yes
Yes	Landing Width (in)	60.0	Yes	DWS Contrast?	Yes
Yes	Landing Slope (%)	0.1	Yes	DWS Length (in)	24.5
No	Landing X Slope (%)	3.1	Yes	DWS Full Width?	Yes
N/A	Landing Curb? (Y/N)	No	Yes	DWS Offset (in)	0.0
N/A	Shared Landing?	No			
Yes	Gutter Ponding?	No	Yes	Gutter Slope (%)	5.0
Yes	Gutter Lip Ht (in)	0.0	Yes	Gutter X Slope (%)	1.0
N/A	Painted X Walk1?	No	N/A	Painted X Walk2?	N/A
	X Walk 1 Direction	To W		X Walk 2 Direction	N/A
N/A	X Walk 1 Width (in)	N/A	N/A	X Walk 2 Width (in)	N/A
	X Walk 1 Slope (%)	1.7		X Walk 2 Slope (%)	N/A
	X Walk 1 X Slope (%)	1.6		X Walk 2 X Slope (%)	N/A

N/A	Ramp inside XWalk1?	N/A	N/A	Ramp inside XWalk2?	N/A
	Road Slope (%)	N/A	N/A	Clear Space?	Yes
	Road X Slope (%)	N/A	N/A	Clear Space to XWalk (in)	N/A
Yes	Any Obstructions?	No	Yes	Storm Grate/Utility Hazard?	No
	Obstruction Type			Storm Grate/Utility Type	
		N/A			N/A
			Yes	Surface Condition? (G/P)	Good

Possible Solutions:

Remove & Replace Entire Ramp.

Total Cost: \$ 1850.00
