Access Compliance Report Public Rights-of-Way (Curb Ramps)

Intersection ID: 25541 Main Street: LITTLE_AV Cross Street: WALSH_BV Location: NE ADA ID: A289FC62F458 Ramp Type: PerpDiag Initial Pass/Fail: Fail **Overall Compliance: No Severity Score:** 25

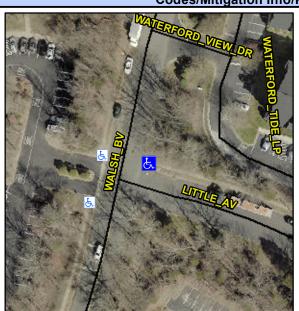
Field Measurements/Component Compliance						
	Compliance Description		Data	Comp	oliance Description	Data
	N/A	Ramp Length (in)	62.0	No	Ramp Slope (%)	10.7
	Yes	Ramp Width (in)	51.0	No	Ramp XSlope (%)	5.7
	N/A	Flare Type LT	N/A	N/A	Flare Type RT	N/A
	N/A	Flare Slope LT (%)	N/A	N/A	Flare Slope RT (%)	N/A
	N/A	Flare Traversable LT?	N/A	N/A	Flare Traversable RT?	N/A
	N/A	Landing Length (in)	N/A	N/A	DWS Provided?	N/A
	N/A	Landing Width (in)	N/A	N/A	DWS Contrast?	N/A
	N/A	Landing Slope (%)	N/A	N/A	DWS Length (in)	N/A
	N/A	Landing X Slope (%)	N/A	N/A	DWS Full Width?	N/A
	N/A	Landing Curb? (Y/N)	N/A	N/A	DWS Offset (in)	N/A
	N/A	Shared Landing?	N/A			
	N/A	Gutter Ponding?	N/A	N/A	Gutter Slope (%)	N/A
	N/A	Gutter Lip Ht (in)	N/A	N/A	Gutter X Slope (%)	N/A
	N/A	Painted X Walk1?	No	N/A	Painted X Walk2?	No
		X Walk 1 Direction	To NW		X Walk 2 Direction	To SW
	N/A	X Walk 1 Width (in)	N/A	N/A	X Walk 2 Width (in)	N/A
		X Walk 1 Slope (%)	0.1		X Walk 2 Slope (%)	2.4

X Walk 1 X Slope (%)	1.3		X Walk 2 X Slope (%)	0.2
	N/A	Ramp inside XWalk1?	N/A	N/A	Ramp inside XWalk2?	N/A
		Road Slope (%)	0.7	N/A	Clear Space?	N/A
		Road X Slope (%)	1.9	N/A	Clear Space to XWalk (in)	N/A
	N/A	Any Obstructions?	N/A	N/A	Storm Grate/Utility Hazard?	N/A
		Obstruction Type			Storm Grate/Utility Type	
			N/A			N/A
				Yes	Surface Condition? (G/P)	Good
, de	79.

Possible Solutions: Remove & Replace Curb Ramp With Two New Directional Ramps or Equivalent. Surveyor Notes: N/A PROW/ADA: Not Found, R304.2.2, R304.5.3
