Access Compliance Report

Public Rights-of-Way

(Curb Ramps)

Intersection ID: 3307	Main Street: SUTTONVIEW_DR	Cross Street: LOOKOUT_POINT_DR	Location: S
ADA ID: A28C333C93F6	Ramp Type: Perp	Initial Pass/Fail: Pass	Overall Compliance: No
Codes/Mitigation Info/Possible Solution		Field Measurements/Component Compliance	
Severity Score: 2.5

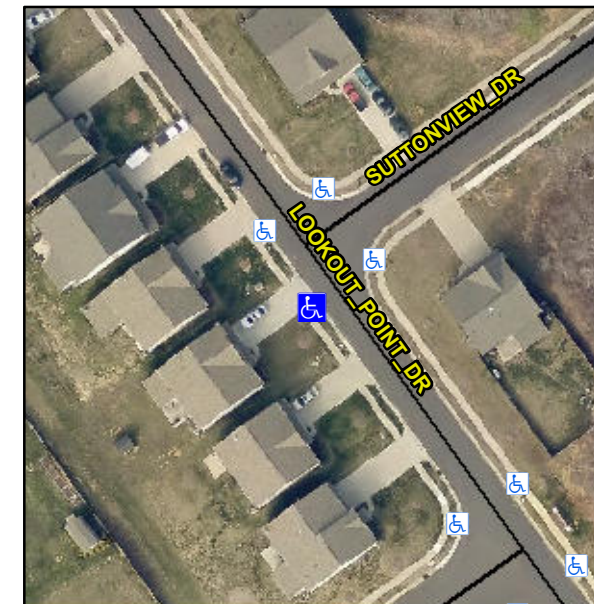
Compliance	Description	Data	Compliance	Description	Data
N/A	Ramp Length (in)	48.0	Yes	Ramp Slope (%)	5.2
Yes	Ramp Width (in)	48.0	Yes	Ramp XSlope (%)	1.0
N/A	Flare Type LT	None	N/A	Flare Type RT	N/A
N/A	Flare Slope LT (%)	N/A	Yes	Flare Slope RT (%)	7.8
N/A	Flare Traversable LT?	N/A	N/A	Flare Traversable RT?	Yes
No	Landing Length (in)	47.5	Yes	DWS Provided?	Yes
Yes	Landing Width (in)	50.0	Yes	DWS Contrast?	Yes
No	Landing Slope (%)	4.1	Yes	DWS Length (in)	24.0
Yes	Landing X Slope (%)	0.7	No	DWS Full Width?	No
N/A	Landing Curb? (Y/N)	No	No	DWS Offset (in)	4.5
N/A	Shared Landing?	No			
Yes	Gutter Ponding?	No	Yes	Gutter Slope (%)	1.1
Yes	Gutter Lip Ht (in)	0.0	Yes	Gutter X Slope (%)	0.9
N/A	Painted X Walk1?	No	N/A	Painted X Walk2?	N/A
	X Walk 1 Direction	To NE		X Walk 2 Direction	N/A
N/A	X Walk 1 Width (in)	N/A	N/A	X Walk 2 Width (in)	N/A
	X Walk 1 Slope (%)	1.7		X Walk 2 Slope (%)	N/A
	X Walk 1 X Slope (%)	1.0		X Walk 2 X Slope (%)	N/A

N/A	Ramp inside XWalk1?	N/A	N/A	Ramp inside XWalk2?	N/A
	Road Slope (%)	N/A	N/A	Clear Space?	Yes
	Road X Slope (%)	N/A	N/A	Clear Space to XWalk (in)	N/A
Yes	Any Obstructions?	No	Yes	Storm Grate/Utility Hazard?	No
	Obstruction Type			Storm Grate/Utility Type	
		N/A			N/A
			Yes	Surface Condition? (G/P)	Good

Possible Solutions:

Remove & Replace Entire Ramp.
