Access Compliance Report

Public Rights-of-Way

(Curb Ramps)

Intersection ID: 12618	Main Street: E_5TH_ST	Cross Street: N_CALDWELL_ST	Location: NE
ADA ID: A29702C2F951	Ramp Type: BlendTrans2	Initial Pass/Fail: Pass	Overall Compliance: No
			Severity Score: 37.75

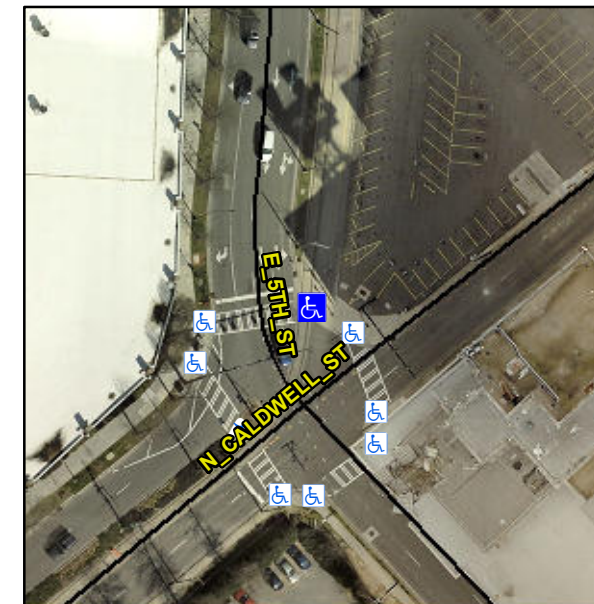
Compliance	Description	Data	Compliance	Description	Data
N/A	Ramp Length (in)	82.0	Yes	BlendTrans Slope (%)	2.4
Yes	Ramp Width (in)	80.0	No	BlendTrans XSlope (%)	2.4
N/A	Flare Type LT	Sloped	N/A	Flare Type RT	Sloped
Yes	Flare Slope LT (%)	2.7	Yes	Flare Slope RT (%)	4.9
N/A	Flare Traversable LT?	Yes	N/A	Flare Traversable RT?	Yes
N/A	Landing Length (in)	N/A	Yes	DWS Provided?	Yes
N/A	Landing Width (in)	N/A	Yes	DWS Contrast?	Yes
N/A	Landing Slope (%)	N/A	Yes	DWS Length (in)	25.0
N/A	Landing X Slope (%)	N/A	No	DWS Full Width?	No
N/A	Landing Curb? (Y/N)	No	Yes	DWS Offset (in)	0.0
N/A	Shared Landing?	No			
Yes	Gutter Ponding?	No	Yes	Gutter Slope (%)	0.4
No	Gutter Lip Ht (in)	1.0	Yes	Gutter X Slope (%)	1.2
N/A	Painted X Walk1?	Yes	N/A	Painted X Walk2?	N/A
	X Walk 1 Direction	To NW		X Walk 2 Direction	N/A
	X Walk 1 Width (in)	121.0		X Walk 2 Width (in)	N/A
	X Walk 1 Slope (%)	4.6		X Walk 2 Slope (%)	N/A
	X Walk 1 X Slope (%)	0.7		X Walk 2 X Slope (%)	N/A

Yes	Ramp inside XWalk1?	Yes	N/A	Ramp inside XWalk2?	N/A
	Road Slope (%)	0.7		Clear Space?	Yes
	Road X Slope (%)	4.6	N/A	Clear Space to XWalk (in)	N/A
No	Any Obstructions?	Yes	Yes	Storm Grate/Utility Hazard?	No
	Obstruction Type			Storm Grate/Utility Type	
				CDOT VAULT 0.5	N/A
			Yes	Surface Condition? (G/P)	Good
			N/A	Curb Slope (%)	0.6

Remove & Replace Curb Ramp With Two New Directional Ramps or Equivalent. Grind Gutter Lip. Relocate Obstruction.
