Access Compliance Report

Public Rights-of-Way

(Curb Ramps)

Intersection ID: 9440	Main Street: BRADFORD_DR	Cross Street: EDGEWOOD_RD	Location: S
ADA ID: A2ACFB2ADA59	Ramp Type: Perp	Initial Pass/Fail: Fail	Overall Compliance: No
Codes/Mitigation Info/Possible Solution		Field Measurements/Component Compliance	
Severity Score: 13.75

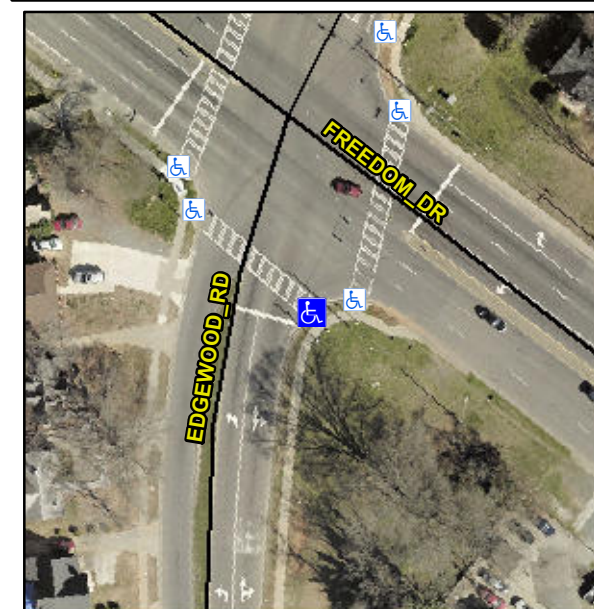
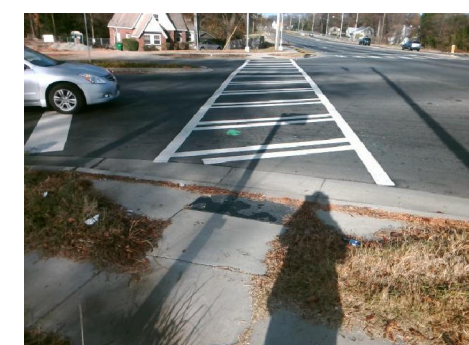
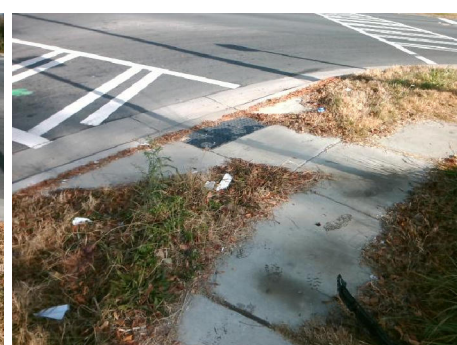
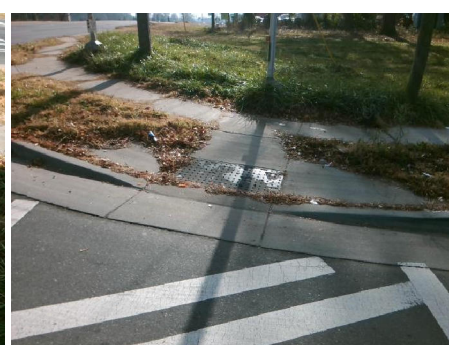
Not Found, R304.2.2

Compliance	Description	Data	Compliance	Description	Data
N/A	Ramp Length (in)	60.0	No	Ramp Slope (%)	8.4
Yes	Ramp Width (in)	48.0	Yes	Ramp XSlope (%)	2.2
N/A	Flare Type LT	N/A	N/A	Flare Type RT	N/A
N/A	Flare Slope LT (%)	N/A	N/A	Flare Slope RT (%)	N/A
N/A	Flare Traversable LT?	N/A	N/A	Flare Traversable RT?	N/A
N/A	Landing Length (in)	N/A	N/A	DWS Provided?	N/A
N/A	Landing Width (in)	N/A	N/A	DWS Contrast?	N/A
N/A	Landing Slope (%)	N/A	N/A	DWS Length (in)	N/A
N/A	Landing X Slope (%)	N/A	N/A	DWS Full Width?	N/A
N/A	Landing Curb? (Y/N)	N/A	N/A	DWS Offset (in)	N/A
N/A	Shared Landing?	N/A			
N/A	Gutter Ponding?	N/A	N/A	Gutter Slope (%)	N/A
N/A	Gutter Lip Ht (in)	N/A	N/A	Gutter X Slope (%)	N/A
N/A	Painted X Walk1?	Yes	N/A	Painted X Walk2?	N/A
	X Walk 1 Direction	To NW		X Walk 2 Direction	N/A
N/A	X Walk 1 Width (in)	121.0	N/A	X Walk 2 Width (in)	N/A
	X Walk 1 Slope (%)	0.7		X Walk 2 Slope (%)	N/A
	X Walk 1 X Slope (%)	4.5		X Walk 2 X Slope (%)	N/A

N/A	Ramp inside XWalk1?	Yes	N/A	Ramp inside XWalk2?	N/A
	Road Slope (%)	N/A	N/A	Clear Space?	N/A
	Road X Slope (%)	N/A	N/A	Clear Space to XWalk (in)	N/A
N/A	Any Obstructions?	N/A	N/A	Storm Grate/Utility Hazard?	N/A
	Obstruction Type			Storm Grate/Utility Type	
		N/A			N/A
			Yes	Surface Condition? (G/P)	Good

Possible Solutions:

Remove & Replace Entire Ramp.
