Access Compliance Report

Public Rights-of-Way

(Curb Ramps)

Intersection ID: 47902	Main Street: SPUR_RANCH_RD	Cross Street: ROUND_ROCK_RD	Location: SE
ADA ID: A2B480590D66	Ramp Type: PerpDiag	Initial Pass/Fail: Fail	Overall Compliance: No
		Severity Score: 8.75

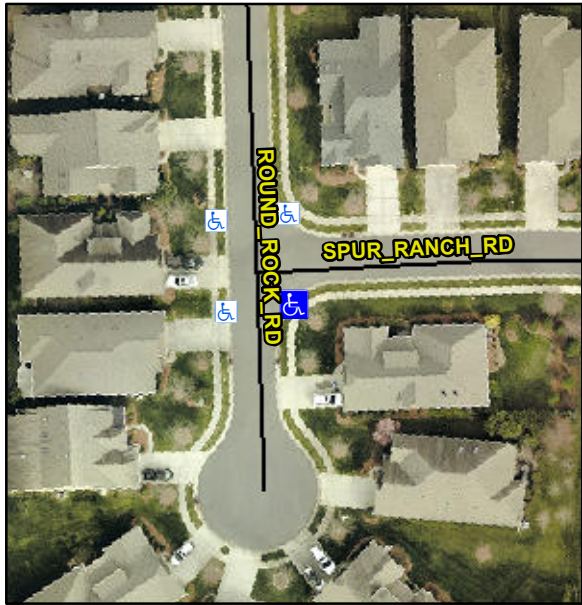
Possible Solutions:		Compliance	Description	Data	Compliance	Description	Data
	Remove & Replace Curb Ramp With Two New Directional Ramps or Equivalent.		N/A	Ramp Length (in)	46.0	Yes	Ramp Slope (%)	6.0
			No	Ramp Width (in)	46.0	Yes	Ramp XSlope (%)	1.4
			N/A	Flare Type LT	N/A	N/A	Flare Type RT	N/A
			N/A	Flare Slope LT (%)	N/A	N/A	Flare Slope RT (%)	N/A
			N/A	Flare Traversable LT?	N/A	N/A	Flare Traversable RT?	N/A
			N/A	Landing Length (in)	N/A	N/A	DWS Provided?	N/A
			N/A	Landing Width (in)	N/A	N/A	DWS Contrast?	N/A
			N/A	Landing Slope (%)	N/A	N/A	DWS Length (in)	N/A
			N/A	Landing X Slope (%)	N/A	N/A	DWS Full Width?	N/A
Surveyor Notes:	N/A		N/A	Landing Curb? (Y/N)	N/A	N/A	DWS Offset (in)	N/A
			N/A	Shared Landing?	N/A			
	PROW/ADA:		N/A	Gutter Ponding?	N/A	N/A	Gutter Slope (%)	N/A
	Not Found, R304.5.1		N/A	Gutter Lip Ht (in)	N/A	N/A	Gutter X Slope (%)	N/A

N/A	Painted X Walk1?	No	N/A	Painted X Walk2?	No
				X Walk 1 Direction	To NE		X Walk 2 Direction	To NW
			N/A	X Walk 1 Width (in)	N/A	N/A	X Walk 2 Width (in)	N/A
				X Walk 1 Slope (%)	0.7		X Walk 2 Slope (%)	1.2
				X Walk 1 X Slope (%)	0.8		X Walk 2 X Slope (%)	0.4
			N/A	Ramp inside XWalk1?	N/A	N/A	Ramp inside XWalk2?	N/A
			Road Slope (%)	0.3	N/A	Clear Space?	N/A	
			Road X Slope (%)	1.2	N/A	Clear Space to XWalk (in)	N/A	
		N/A	Any Obstructions?	N/A	N/A	Storm Grate/Utility Hazard?	N/A	
			Obstruction Type			Storm Grate/Utility Type		
					N/A		N/A	
					Yes	Surface Condition? (G/P)	Good

Not Found, R304.5.1

Remove & Replace Curb Ramp With Two New Directional Ramps or Equivalent.
