## **Access Compliance Report Public Rights-of-Way** (Curb Ramps)

Intersection ID: 30337 Main Street: DULIN CREEK BV Cross Street: GOLD PAN RD Location: NW **Overall Compliance: No Severity Score:** ADA ID: A2B4814A7678 Ramp Type: BlendTrans1 Initial Pass/Fail: Fail 12.5

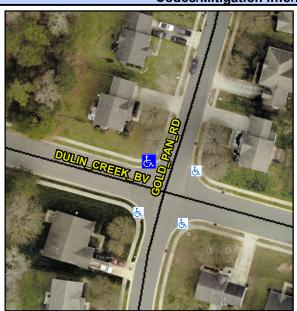
Total Cost: 3200.00 Compliance Description Data Compliance Description Data Yes BlendTrans Slope (%) N/A Ramp Length (in) 48.5 3.7 51.5 No Yes Ramp Width (in) BlendTrans XSlope (%) 6.9 N/A N/A Flare Type LT N/A Flare Type RT N/A N/A Flare Slope LT (%) N/A N/A Flare Slope RT (%) N/A N/A Flare Traversable LT? N/A N/A Flare Traversable RT? N/A N/A Landing Length (in) N/A N/A **DWS Provided?** N/A N/A Landing Width (in) N/A N/A **DWS Contrast?** N/A N/A N/A N/A Landing Slope (%) DWS Length (in) N/A N/A Landing X Slope (%) N/A N/A DWS Full Width? N/A N/A Landing Curb? (Y/N) N/A N/A DWS Offset (in) N/A N/A N/A Shared Landing? N/A **Gutter Ponding?** N/A N/A Gutter Slope (%) N/A N/A Gutter Lip Ht (in) N/A N/A Gutter X Slope (%) N/A N/A Painted X Walk1? No N/A Painted X Walk2? No X Walk 1 Direction To S X Walk 2 Direction To E N/A X Walk 1 Width (in) X Walk 2 Width (in) N/A X Walk 1 Slope (%) X Walk 2 Slope (%) 1.4 5.4 X Walk 1 X Slope (%) 6.1 X Walk 2 X Slope (%) 2.9 N/A N/A Ramp inside XWalk2? N/A N/A Ramp inside XWalk1? Road Slope (%) 6.0 Clear Space? N/A Road X Slope (%) 1.7 N/A Clear Space to XWalk (in) N/A N/A N/A N/A Any Obstructions? Storm Grate/Utility Hazard? N/A **Obstruction Type**

**GOLD PAN RD** StopSign **DULIN CREEK BV** None Possible Solutions: Remove & Replace Curb Ramp With Two New Directional Ramps or Equivalent. Surveyor Notes: N/A PROW/ADA: Not Found, R304.5.3
