Access Compliance Report Public Rights-of-Way (Curb Ramps)

Intersection ID: 23951 Main Street: S_TRYON_ST Cross Street: CHOATE_CR Location: NW

ADA ID: A2C5A7B8BCBE Ramp Type: Perp Initial Pass/Fail: Fail Overall Compliance: No Severity Score: 12.5

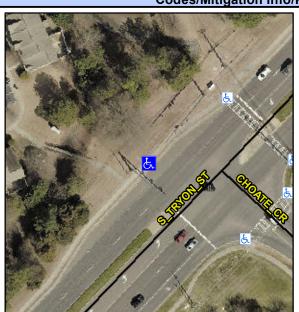
Field Measurements/Component Compliance					
Comp	liance Description	Data	Comp	liance Description	Data
N/A	Ramp Length (in)	91.0	No	Ramp Slope (%)	8.6
Yes	Ramp Width (in)	48.0	Yes	Ramp XSlope (%)	0.1
N/A	Flare Type LT	N/A	N/A	Flare Type RT	N/A
N/A	Flare Slope LT (%)	N/A	N/A	Flare Slope RT (%)	N/A
N/A	Flare Traversable LT?	N/A	N/A	Flare Traversable RT?	N/A
N/A	Landing Length (in)	N/A	N/A	DWS Provided?	N/A
N/A	Landing Width (in)	N/A	N/A	DWS Contrast?	N/A
N/A	Landing Slope (%)	N/A	N/A	DWS Length (in)	N/A
N/A	Landing X Slope (%)	N/A	N/A	DWS Full Width?	N/A
N/A	Landing Curb? (Y/N)	N/A	N/A	DWS Offset (in)	N/A
N/A	Shared Landing?	N/A			
N/A	Gutter Ponding?	N/A	N/A	Gutter Slope (%)	N/A
N/A	Gutter Lip Ht (in)	N/A	N/A	Gutter X Slope (%)	N/A
N/A	Painted X Walk1?	No	N/A	Painted X Walk2?	N/A
	X Walk 1 Direction	To SE		X Walk 2 Direction	N/A
N/A	X Walk 1 Width (in)	N/A	N/A	X Walk 2 Width (in)	N/A
	X Walk 1 Slope (%)	2.1		X Walk 2 Slope (%)	N/A

X Walk 1 X Slope (%)	0.2		X Walk 2 X Slope (%)	N/A
N/A	Ramp inside XWalk1?	N/A	N/A	Ramp inside XWalk2?	N/A
	Road Slope (%)	N/A	N/A	Clear Space?	N/A
	Road X Slope (%)	N/A	N/A	Clear Space to XWalk (in)	N/A
N/A	Any Obstructions?	N/A	N/A	Storm Grate/Utility Hazard?	N/A
	Obstruction Type			Storm Grate/Utility Type	
		N/A			N/A
			Yes	Surface Condition? (G/P)	Good

Possible Solutions:					
Remove & Replace Entire Ramp.					
Surveyer Netee:					
Surveyor Notes:					
N/A					
PROW/ADA:					
Not Found, R304.2.2					
·
