Access Compliance Report

Public Rights-of-Way

(Curb Ramps)

Intersection ID: 12828	Main Street: W_MOREHEAD_ST	Cross Street: S_CHURCH_ST	Location: SE
ADA ID: A2D333D44994	Ramp Type: PerpDiag	Initial Pass/Fail: Fail	Overall Compliance: No
			Severity Score: 13.75

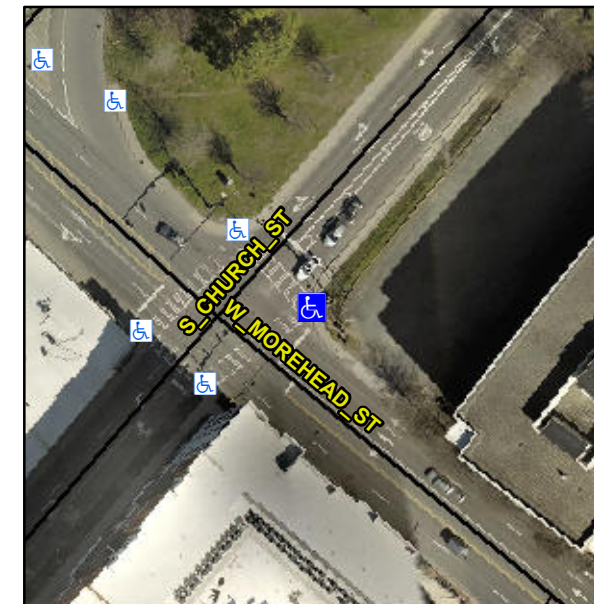
Not Found, R304.2.2

Compliance	Description	Data	Compliance	Description	Data
N/A	Ramp Length (in)	59.0	No	Ramp Slope (%)	8.9
Yes	Ramp Width (in)	48.0	Yes	Ramp XSlope (%)	2.4
N/A	Flare Type LT	N/A	N/A	Flare Type RT	N/A
N/A	Flare Slope LT (%)	N/A	N/A	Flare Slope RT (%)	N/A
N/A	Flare Traversable LT?	N/A	N/A	Flare Traversable RT?	N/A
N/A	Landing Length (in)	N/A	N/A	DWS Provided?	N/A
N/A	Landing Width (in)	N/A	N/A	DWS Contrast?	N/A
N/A	Landing Slope (%)	N/A	N/A	DWS Length (in)	N/A
N/A	Landing X Slope (%)	N/A	N/A	DWS Full Width?	N/A
N/A	Landing Curb? (Y/N)	N/A	N/A	DWS Offset (in)	N/A
N/A	Shared Landing?	N/A			
N/A	Gutter Ponding?	N/A	N/A	Gutter Slope (%)	N/A
N/A	Gutter Lip Ht (in)	N/A	N/A	Gutter X Slope (%)	N/A
N/A	Painted X Walk1?	Yes	N/A	Painted X Walk2?	Yes
	X Walk 1 Direction	To NW		X Walk 2 Direction	To SW
N/A	X Walk 1 Width (in)	100.0	N/A	X Walk 2 Width (in)	99.0
	X Walk 1 Slope (%)	0.9		X Walk 2 Slope (%)	1.5
	X Walk 1 X Slope (%)	2.2		X Walk 2 X Slope (%)	1.9

N/A	Ramp inside XWalk1?	Yes	N/A	Ramp inside XWalk2?	Yes
	Road Slope (%)	2.7	N/A	Clear Space?	N/A
	Road X Slope (%)	0.2	N/A	Clear Space to XWalk (in)	N/A
N/A	Any Obstructions?	N/A	N/A	Storm Grate/Utility Hazard?	N/A
	Obstruction Type			Storm Grate/Utility Type	
		N/A			N/A
			Yes	Surface Condition? (G/P)	Good

Remove & Replace Curb Ramp With Two New Directional Ramps or Equivalent.
