# Access Compliance Report

## Public Rights-of-Way

### (Curb Ramps)

Intersection ID: 20966	Main Street: Kelford_LN	Cross Street: Shadowstone_DR	Location: E
ADA ID: A2D9990CB3FF	Ramp Type: PerpDiag	Initial Pass/Fail: Fail	Overall Compliance: No
Codes/Mitigation Info/Possible Solution		Field Measurements/Component Compliance	
Severity Score: 21.25

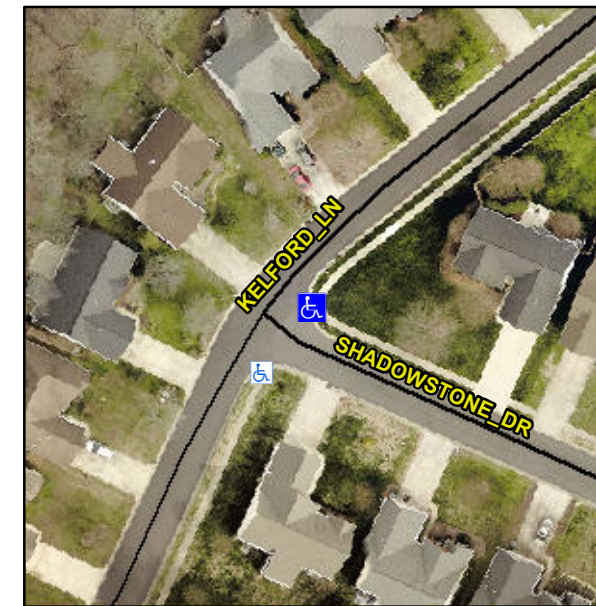
**Not Found, R304.5.1, R304.2.2**

Compliance	Description	Data	Compliance	Description	Data
N/A	Ramp Length (in)	84.0	No	Ramp Slope (%)	10.5
No	Ramp Width (in)	38.0	Yes	Ramp XSlope (%)	2.0
N/A	Flare Type LT	N/A	N/A	Flare Type RT	N/A
N/A	Flare Slope LT (%)	N/A	N/A	Flare Slope RT (%)	N/A
N/A	Flare Traversable LT?	N/A	N/A	Flare Traversable RT?	N/A
N/A	Landing Length (in)	N/A	N/A	DWS Provided?	N/A
N/A	Landing Width (in)	N/A	N/A	DWS Contrast?	N/A
N/A	Landing Slope (%)	N/A	N/A	DWS Length (in)	N/A
N/A	Landing X Slope (%)	N/A	N/A	DWS Full Width?	N/A
N/A	Landing Curb? (Y/N)	N/A	N/A	DWS Offset (in)	N/A
N/A	Shared Landing?	N/A			
N/A	Gutter Ponding?	N/A	N/A	Gutter Slope (%)	N/A
N/A	Gutter Lip Ht (in)	N/A	N/A	Gutter X Slope (%)	N/A
N/A	Painted X Walk1?	No	N/A	Painted X Walk2?	No
	X Walk 1 Direction	To NW		X Walk 2 Direction	To SW
N/A	X Walk 1 Width (in)	N/A	N/A	X Walk 2 Width (in)	N/A
	X Walk 1 Slope (%)	1.5		X Walk 2 Slope (%)	6.3
	X Walk 1 X Slope (%)	5.4		X Walk 2 X Slope (%)	3.9

N/A	Ramp inside XWalk1?	N/A	N/A	Ramp inside XWalk2?	N/A
	Road Slope (%)	0.9	N/A	Clear Space?	N/A
	Road X Slope (%)	5.8	N/A	Clear Space to XWalk (in)	N/A
N/A	Any Obstructions?	N/A	N/A	Storm Grate/Utility Hazard?	N/A
	Obstruction Type			Storm Grate/Utility Type	
		N/A			N/A
			Yes	Surface Condition? (G/P)	Good

**Remove & Replace Curb Ramp With Two New Directional Ramps or Equivalent.**

Total Cost: \$ 3200.00
