# Access Compliance Report

## Public Rights-of-Way

### (Curb Ramps)

| Intersection ID: 48633 | Main Street: GRANDE_HEIGHTS_DR | Cross Street: MILLSTREAM_RIDGE_DR | Location: E |

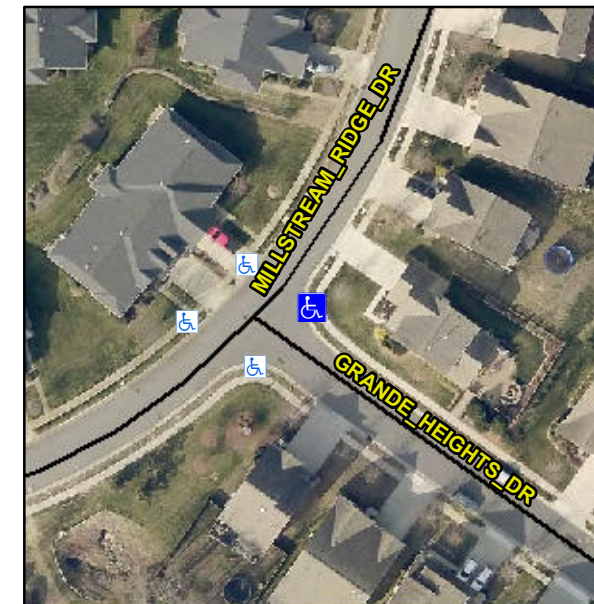
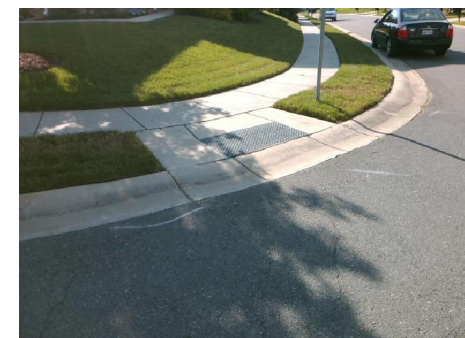
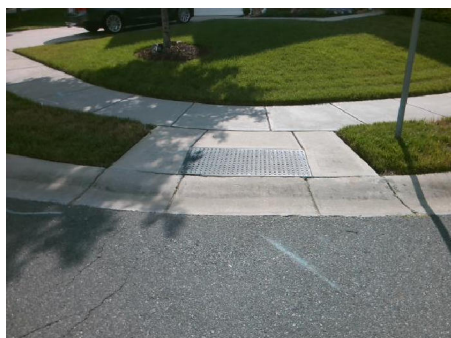
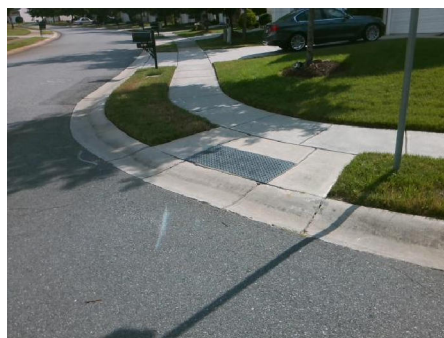
**Not Found, R304.5.3, R304.2.1, R305.1.4**

| Compliance | Description | Data | Compliance | Description | Data |
|---|---|---|---|---|---|
| Yes | Ramp Width (in) | 48.0 | No | BlendTrans XSlope (%) | 3.4 |
| No | Landing Length (in) | 47.0 | Yes | DWS Provided? | Yes |
| No | Landing Width (in) | 40.0 | Yes | DWS Contrast? | Yes |
| No | Landing X Slope (%) | 4.2 | No | DWS Full Width? | No |

**Remove & Replace Curb Ramp With Two New Directional Ramps or Equivalent.**
