# Access Compliance Report

## Public Rights-of-Way

### (Curb Ramps)

Intersection ID: 21108	Main Street: PARK_SOUTH_DR	Cross Street: OLD_REID_RD	Location: E
ADA ID: A2E8377605D5	Ramp Type: PerpDiag	Initial Pass/Fail: Fail	Overall Compliance: No
Severity Score: 10			
Codes/Mitigation Info/Possible Solution		Field Measurements/Component Compliance

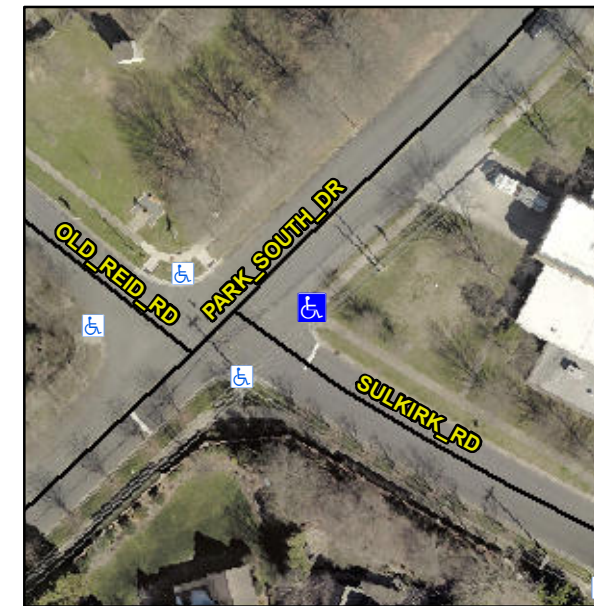
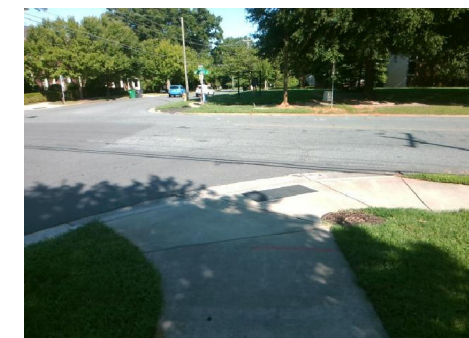
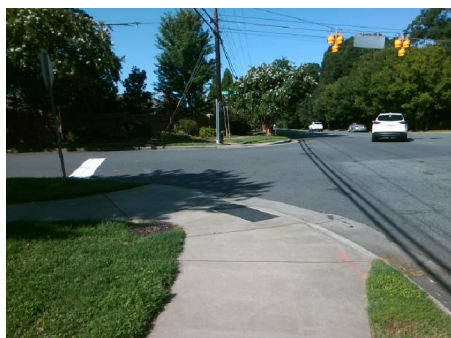
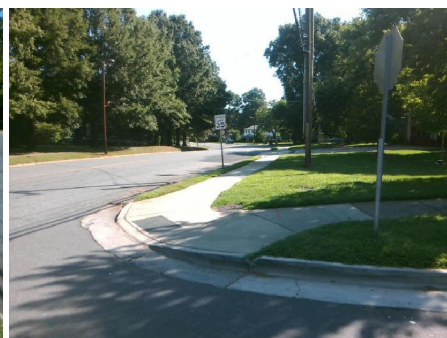
**Not Found, R304.5.1, R304.5.3**

Compliance	Description	Data	Compliance	Description	Data
N/A	Ramp Length (in)	68.0	Yes	Ramp Slope (%)	8.1
No	Ramp Width (in)	44.0	No	Ramp XSlope (%)	3.2
N/A	Flare Type LT	N/A	N/A	Flare Type RT	N/A
N/A	Flare Slope LT (%)	N/A	N/A	Flare Slope RT (%)	N/A
N/A	Flare Traversable LT?	N/A	N/A	Flare Traversable RT?	N/A
N/A	Landing Length (in)	N/A	N/A	DWS Provided?	N/A
N/A	Landing Width (in)	N/A	N/A	DWS Contrast?	N/A
N/A	Landing Slope (%)	N/A	N/A	DWS Length (in)	N/A
N/A	Landing X Slope (%)	N/A	N/A	DWS Full Width?	N/A
N/A	Landing Curb? (Y/N)	N/A	N/A	DWS Offset (in)	N/A
N/A	Shared Landing?	N/A			
N/A	Gutter Ponding?	N/A	N/A	Gutter Slope (%)	N/A
N/A	Gutter Lip Ht (in)	N/A	N/A	Gutter X Slope (%)	N/A
N/A	Painted X Walk1?	No	N/A	Painted X Walk2?	No
	X Walk 1 Direction	To NW		X Walk 2 Direction	To SW
N/A	X Walk 1 Width (in)	N/A	N/A	X Walk 2 Width (in)	N/A
	X Walk 1 Slope (%)	0.9		X Walk 2 Slope (%)	3.0
	X Walk 1 X Slope (%)	4.1		X Walk 2 X Slope (%)	0.5

N/A	Ramp inside XWalk1?	N/A	N/A	Ramp inside XWalk2?	N/A
	Road Slope (%)	2.1	N/A	Clear Space?	N/A
	Road X Slope (%)	3.3	N/A	Clear Space to XWalk (in)	N/A
N/A	Any Obstructions?	N/A	N/A	Storm Grate/Utility Hazard?	N/A
	Obstruction Type			Storm Grate/Utility Type	
		N/A			N/A
			Yes	Surface Condition? (G/P)	Good

**Remove & Replace Curb Ramp With Two New Directional Ramps or Equivalent.**
