Access Compliance Report

Public Rights-of-Way

(Curb Ramps)

Intersection ID: 2396	Main Street: EASTFIELD_RD	Cross Street: HIGHLAND_CREEK_PY	Location: S
ADA ID: A2E8C5635495	Ramp Type: MedianPerp	Initial Pass/Fail: Fail	Overall Compliance: No
		Severity Score: 12.5

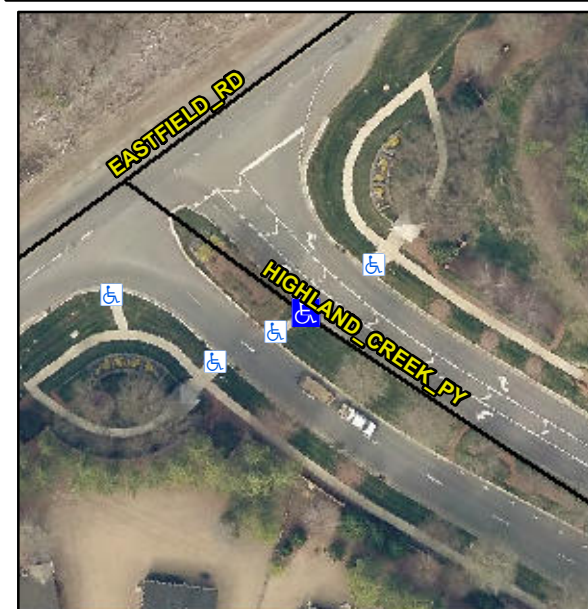
Compliance	Description	Data	Compliance	Description	Data
N/A	Ramp Length (in)	32.0	No	Ramp Slope (%)	11.1
Yes	Ramp Width (in)	48.0	Yes	Ramp XSlope (%)	1.4
N/A	Flare Type LT	N/A	N/A	Flare Type RT	N/A
N/A	Flare Slope LT (%)	N/A	N/A	Flare Slope RT (%)	N/A
N/A	Flare Traversable LT?	N/A	N/A	Flare Traversable RT?	N/A
N/A	Landing Length (in)	N/A	N/A	DWS Provided?	N/A
N/A	Landing Width (in)	N/A	N/A	DWS Contrast?	N/A
N/A	Landing Slope (%)	N/A	N/A	DWS Length (in)	N/A
N/A	Landing X Slope (%)	N/A	N/A	DWS Full Width?	N/A
N/A	Landing Curb? (Y/N)	N/A	N/A	DWS Offset (in)	N/A
N/A	Shared Landing?	N/A			
N/A	Gutter Ponding?	N/A	N/A	Gutter Slope (%)	N/A
N/A	Gutter Lip Ht (in)	N/A	N/A	Gutter X Slope (%)	N/A
N/A	Painted X Walk1?	No	N/A	Painted X Walk2?	N/A
	X Walk 1 Direction	To NE		X Walk 2 Direction	N/A
N/A	X Walk 1 Width (in)	N/A	N/A	X Walk 2 Width (in)	N/A
	X Walk 1 Slope (%)	2.4		X Walk 2 Slope (%)	N/A
	X Walk 1 X Slope (%)	0.6		X Walk 2 X Slope (%)	N/A

Remove & Replace Entire Ramp.
