Access Compliance Report

Public Rights-of-Way

(Curb Ramps)

Intersection ID: 10036962	Main Street: S_TRYON_ST	Cross Street: N/A	Location: NE
ADA ID: A2EC491C5EA3	Ramp Type: Perp	Initial Pass/Fail: Fail	Overall Compliance: No
Severity Score: 35			
Codes/Mitigation Info/Possible Solution		Field Measurements/Component Compliance

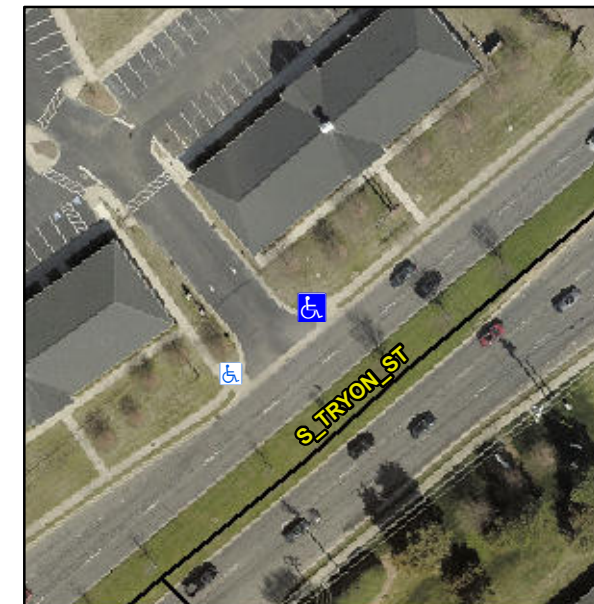
Not Found, R304.5.1, R304.2.2, R304.5.3

Compliance	Description	Data	Compliance	Description	Data
N/A	Ramp Length (in)	29.0	No	Ramp Slope (%)	12.1
No	Ramp Width (in)	46.0	No	Ramp XSlope (%)	4.1
N/A	Flare Type LT	N/A	N/A	Flare Type RT	N/A
N/A	Flare Slope LT (%)	N/A	N/A	Flare Slope RT (%)	N/A
N/A	Flare Traversable LT?	N/A	N/A	Flare Traversable RT?	N/A
N/A	Landing Length (in)	N/A	N/A	DWS Provided?	N/A
N/A	Landing Width (in)	N/A	N/A	DWS Contrast?	N/A
N/A	Landing Slope (%)	N/A	N/A	DWS Length (in)	N/A
N/A	Landing X Slope (%)	N/A	N/A	DWS Full Width?	N/A
N/A	Landing Curb? (Y/N)	N/A	N/A	DWS Offset (in)	N/A
N/A	Shared Landing?	N/A			
N/A	Gutter Ponding?	N/A	N/A	Gutter Slope (%)	N/A
N/A	Gutter Lip Ht (in)	N/A	N/A	Gutter X Slope (%)	N/A
N/A	Painted X Walk1?	No	N/A	Painted X Walk2?	N/A
	X Walk 1 Direction	To W		X Walk 2 Direction	N/A
N/A	X Walk 1 Width (in)	N/A	N/A	X Walk 2 Width (in)	N/A
	X Walk 1 Slope (%)	1.5		X Walk 2 Slope (%)	N/A
	X Walk 1 X Slope (%)	5.6		X Walk 2 X Slope (%)	N/A

N/A	Ramp inside XWalk1?	N/A	N/A	Ramp inside XWalk2?	N/A
	Road Slope (%)	N/A	N/A	Clear Space?	N/A
	Road X Slope (%)	N/A	N/A	Clear Space to XWalk (in)	N/A
N/A	Any Obstructions?	N/A	N/A	Storm Grate/Utility Hazard?	N/A
	Obstruction Type			Storm Grate/Utility Type	
		N/A			N/A
			Yes	Surface Condition? (G/P)	Good

Possible Solutions:

Remove & Replace Entire Ramp.
