# Access Compliance Report

## Public Rights-of-Way

### (Curb Ramps)

| Intersection ID: 28350 | Main Street: REA_RD | Cross Street: LINDAHI_LN | Location: SE |

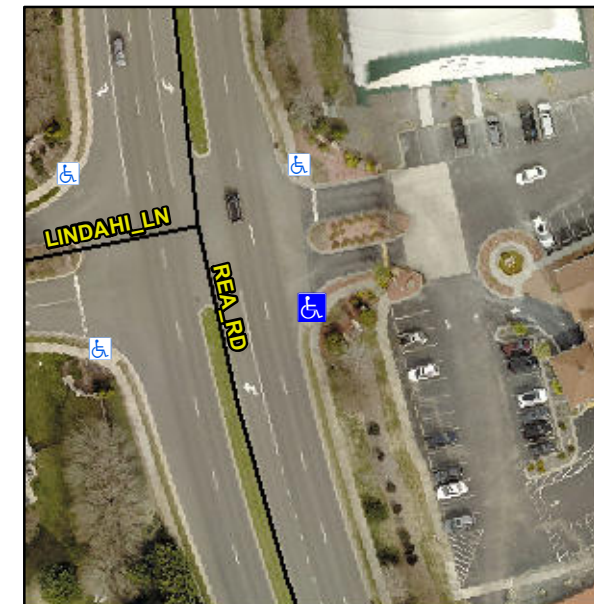
| ADA ID: A2EE6F69B8E8 | Ramp Type: PerpDiag | Initial Pass/Fail: Pass | Overall Compliance: No |
| Severity Score: 12.5 | | | |

**Not Found, R304.2.1, R304.2.2-Perp, R304.3.2-Para, R304.5.3, R305.1.4, R305.2**

| Compliance | Description | Data | Compliance | Description | Data |
|---|---|---|---|---|---|
| No | Landing Length (in) | N/A | Yes | DWS Provided? | Yes |
| No | Landing Width (in) | N/A | Yes | DWS Contrast? | Yes |
| No | Landing Slope (%) | N/A | Yes | DWS Length (in) | 24.0 |
| No | Landing X Slope (%) | N/A | No | DWS Full Width? | No |
| N/A | Landing Curb? (Y/N) | No | No | DWS Offset (in) | 5.0 |

**Remove & Replace Curb Ramp With Two New Directional Ramps or Equivalent.**

Total Cost: \$ 3200.00
