# Access Compliance Report

## Public Rights-of-Way

### (Curb Ramps)

| Intersection ID: 7479 | Main Street: COTTONWOOD_ST | Cross Street: JOE_ST | Location: W |

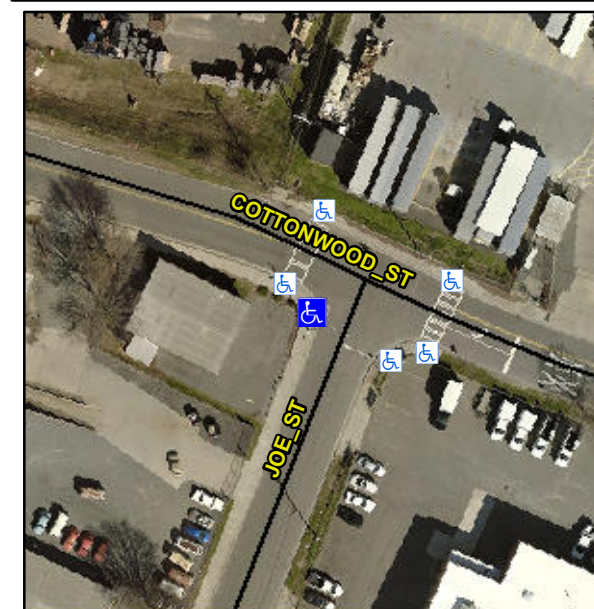
| ADA ID: A2EFB7E55D96 | Ramp Type: Perp | Initial Pass/Fail: Fail | Overall Compliance: No |
| Severity Score: 8.75 | | | |

**Not Found, R304.5.1**

| Compliance | Description | Data | Compliance | Description | Data |
|---|---|---|---|---|---|
| N/A | Ramp Length (in) | 83.0 | Yes | Ramp Slope (%) | 5.7 |
| No | Ramp Width (in) | 47.5 | Yes | Ramp XSlope (%) | 0.5 |

Possible Solutions:

**Remove & Replace Entire Ramp.**

Total Cost: \$ 1850.00
