# Access Compliance Report

## Public Rights-of-Way

### (Curb Ramps)

Intersection ID: 14251	Main Street: CHESTERFIELD_AV	Cross Street: LORNA_ST	Location:	W
ADA ID: A2F0D0DC99C8	Ramp Type: Perp	Initial Pass/Fail: Fail	Overall Compliance: No	Severity Score: 25
Codes/Mitigation Info/Possible Solution		Field Measurements/Component Compliance

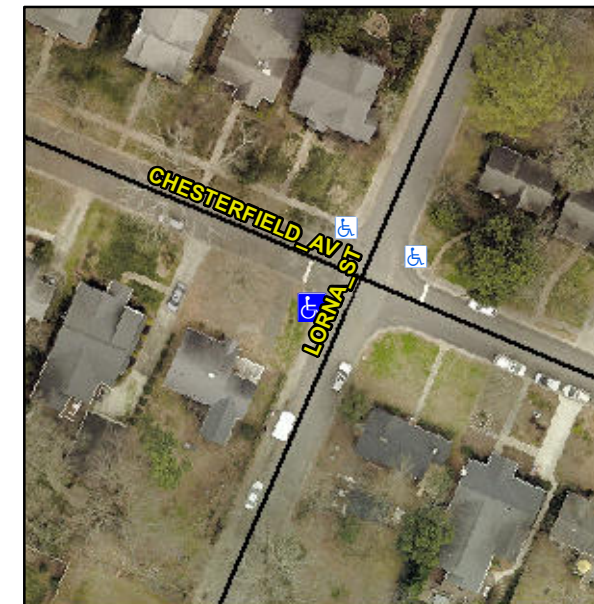
**Not Found, R304.5.3**

Compliance	Description	Data	Compliance	Description	Data
N/A	Ramp Length (in)	60.0	Yes	Ramp Slope (%)	5.9
Yes	Ramp Width (in)	100.0	No	Ramp XSlope (%)	7.3
N/A	Flare Type LT	N/A	N/A	Flare Type RT	N/A
N/A	Flare Slope LT (%)	N/A	N/A	Flare Slope RT (%)	N/A
N/A	Flare Traversable LT?	N/A	N/A	Flare Traversable RT?	N/A
N/A	Landing Length (in)	N/A	N/A	DWS Provided?	N/A
N/A	Landing Width (in)	N/A	N/A	DWS Contrast?	N/A
N/A	Landing Slope (%)	N/A	N/A	DWS Length (in)	N/A
N/A	Landing X Slope (%)	N/A	N/A	DWS Full Width?	N/A
N/A	Landing Curb? (Y/N)	N/A	N/A	DWS Offset (in)	N/A
N/A	Shared Landing?	N/A			
N/A	Gutter Ponding?	N/A	N/A	Gutter Slope (%)	N/A
N/A	Gutter Lip Ht (in)	N/A	N/A	Gutter X Slope (%)	N/A
N/A	Painted X Walk1?	No	N/A	Painted X Walk2?	N/A
	X Walk 1 Direction	To NE		X Walk 2 Direction	N/A
N/A	X Walk 1 Width (in)	N/A	N/A	X Walk 2 Width (in)	N/A
	X Walk 1 Slope (%)	4.0		X Walk 2 Slope (%)	N/A
	X Walk 1 X Slope (%)	5.0		X Walk 2 X Slope (%)	N/A

**Remove & Replace Entire Ramp.**
