Access Compliance Report

Public Rights-of-Way

(Curb Ramps)

Intersection ID: 43765	Main Street: HELENS_LN	Cross Street: EASTFIELD_RD	Location: SW
ADA ID: A2F51E1E1FD9	Ramp Type: Perp	Initial Pass/Fail: Fail	Overall Compliance: No
Severity Score: 13.75			
Codes/Mitigation Info/Possible Solution		Field Measurements/Component Compliance

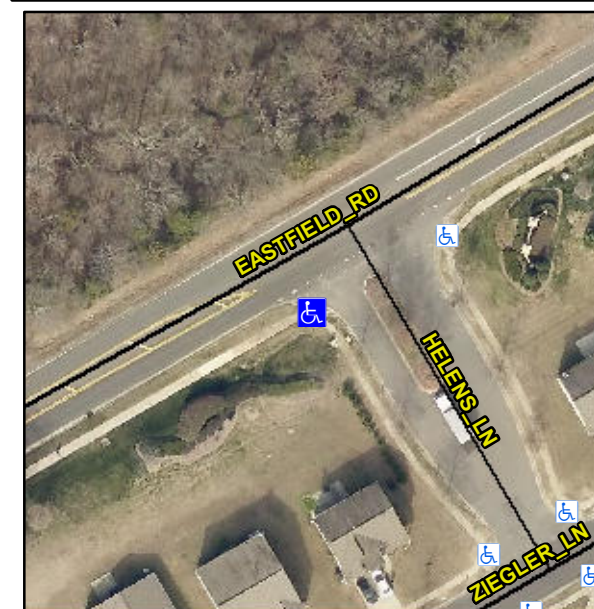
R304.2.2, R304.5.3

Compliance	Description	Data	Compliance	Description	Data
N/A	Ramp Length (in)	47.0	No	Ramp Slope (%)	11.2
Yes	Ramp Width (in)	56.0	No	Ramp XSlope (%)	3.6
N/A	Flare Type LT	N/A	N/A	Flare Type RT	N/A
N/A	Flare Slope LT (%)	N/A	N/A	Flare Slope RT (%)	N/A
N/A	Flare Traversable LT?	N/A	N/A	Flare Traversable RT?	N/A
N/A	Landing Length (in)	N/A	N/A	DWS Provided?	N/A
N/A	Landing Width (in)	N/A	N/A	DWS Contrast?	N/A
N/A	Landing Slope (%)	N/A	N/A	DWS Length (in)	N/A
N/A	Landing X Slope (%)	N/A	N/A	DWS Full Width?	N/A
N/A	Landing Curb? (Y/N)	N/A	N/A	DWS Offset (in)	N/A
N/A	Shared Landing?	N/A			
N/A	Gutter Ponding?	N/A	N/A	Gutter Slope (%)	N/A
N/A	Gutter Lip Ht (in)	N/A	N/A	Gutter X Slope (%)	N/A
N/A	Painted X Walk1?	No	N/A	Painted X Walk2?	N/A
	X Walk 1 Direction	To NW		X Walk 2 Direction	N/A
N/A	X Walk 1 Width (in)	N/A	N/A	X Walk 2 Width (in)	N/A
	X Walk 1 Slope (%)	2.1		X Walk 2 Slope (%)	N/A
	X Walk 1 X Slope (%)	1.7		X Walk 2 X Slope (%)	N/A

N/A	Ramp inside XWalk1?	N/A	N/A	Ramp inside XWalk2?	N/A
	Road Slope (%)	N/A	N/A	Clear Space?	N/A
	Road X Slope (%)	N/A	N/A	Clear Space to XWalk (in)	N/A
N/A	Any Obstructions?	N/A	N/A	Storm Grate/Utility Hazard?	N/A
	Obstruction Type			Storm Grate/Utility Type	
		N/A			N/A
		Yes		Surface Condition? (G/P)	Good

Remove & Replace Entire Ramp.
