# Access Compliance Report

## Public Rights-of-Way

### (Curb Ramps)

Intersection ID: 20810	Main Street: RED_OAK_BV	Cross Street: N/A	Location: NE
ADA ID: A2F8145FE3ED	Ramp Type: Perp	Initial Pass/Fail: Fail	Overall Compliance: No
Severity Score: 37.5			
Codes/Mitigation Info/Possible Solution		Field Measurements/Component Compliance

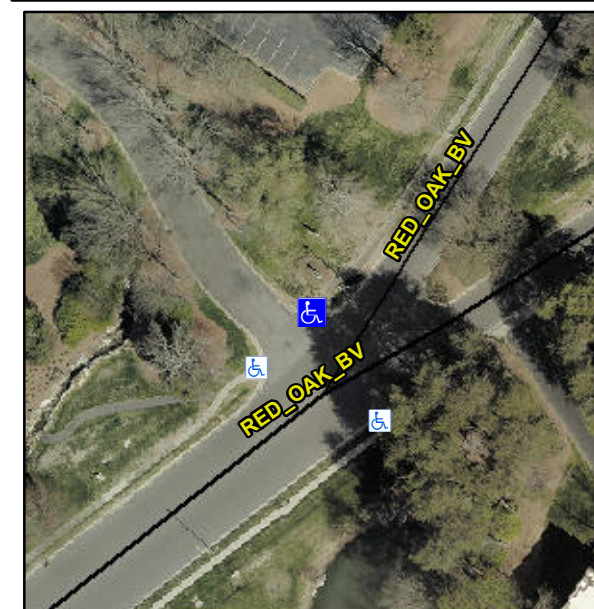
**Not Found, R304.2.2, R304.5.3**

Compliance	Description	Data	Compliance	Description	Data
N/A	Ramp Length (in)	48.0	No	Ramp Slope (%)	12.5
Yes	Ramp Width (in)	48.0	No	Ramp XSlope (%)	6.3
N/A	Flare Type LT	N/A	N/A	Flare Type RT	N/A
N/A	Flare Slope LT (%)	N/A	N/A	Flare Slope RT (%)	N/A
N/A	Flare Traversable LT?	N/A	N/A	Flare Traversable RT?	N/A
N/A	Landing Length (in)	N/A	N/A	DWS Provided?	N/A
N/A	Landing Width (in)	N/A	N/A	DWS Contrast?	N/A
N/A	Landing Slope (%)	N/A	N/A	DWS Length (in)	N/A
N/A	Landing X Slope (%)	N/A	N/A	DWS Full Width?	N/A
N/A	Landing Curb? (Y/N)	N/A	N/A	DWS Offset (in)	N/A
N/A	Shared Landing?	N/A			
N/A	Gutter Ponding?	N/A	N/A	Gutter Slope (%)	N/A
N/A	Gutter Lip Ht (in)	N/A	N/A	Gutter X Slope (%)	N/A
N/A	Painted X Walk1?	No	N/A	Painted X Walk2?	N/A
	X Walk 1 Direction	To W		X Walk 2 Direction	N/A
N/A	X Walk 1 Width (in)	N/A	N/A	X Walk 2 Width (in)	N/A
	X Walk 1 Slope (%)	5.8		X Walk 2 Slope (%)	N/A
	X Walk 1 X Slope (%)	1.9		X Walk 2 X Slope (%)	N/A

N/A	Ramp inside XWalk1?	N/A	N/A	Ramp inside XWalk2?	N/A
	Road Slope (%)	N/A	N/A	Clear Space?	N/A
	Road X Slope (%)	N/A	N/A	Clear Space to XWalk (in)	N/A
N/A	Any Obstructions?	N/A	N/A	Storm Grate/Utility Hazard?	N/A
	Obstruction Type			Storm Grate/Utility Type	
		N/A			N/A
		Yes		Surface Condition? (G/P)	Good

**Remove & Replace Entire Ramp.**

Total Cost: \$ 1850.00
