Access Compliance Report

Public Rights-of-Way

(Curb Ramps)

Intersection ID: 5600	Main Street: N_TRYON_ST	Cross Street: J_M_KEYNES_DR	Location: N
ADA ID: A2F9467CF34F	Ramp Type: Perp	Initial Pass/Fail: Fail	Overall Compliance: No
Severity Score: 10			
Codes/Mitigation Info/Possible Solution		Field Measurements/Component Compliance

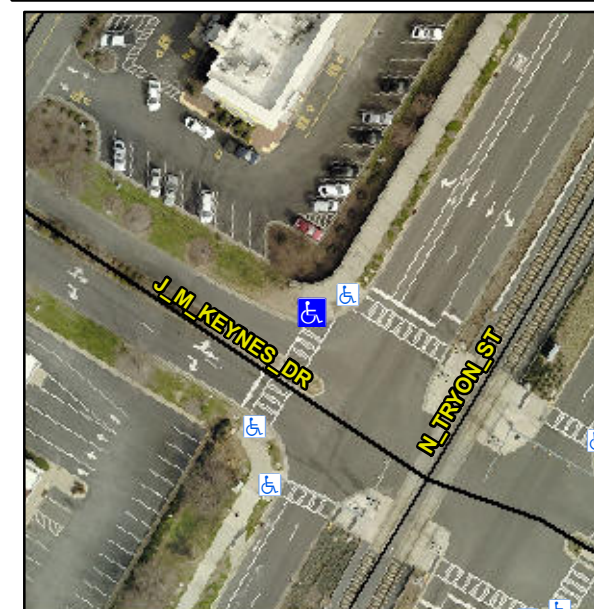
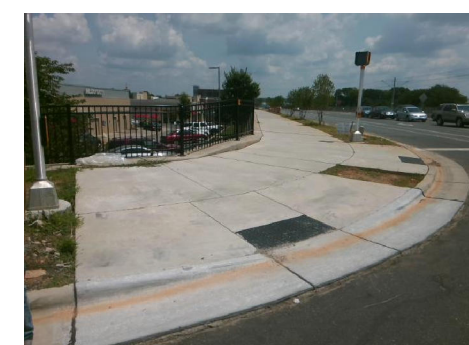
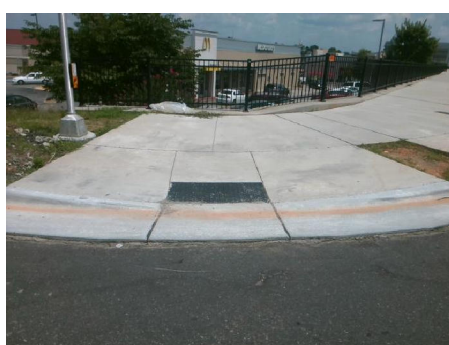
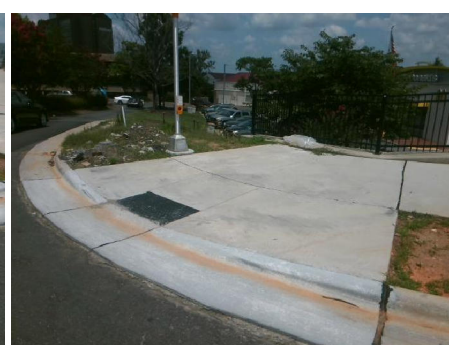
Compliance	Description	Data	Compliance	Description	Data
N/A	Ramp Length (in)	72.0	Yes	Ramp Slope (%)	7.8
No	Ramp Width (in)	47.0	Yes	Ramp XSlope (%)	2.3
N/A	Flare Type LT	N/A	N/A	Flare Type RT	N/A
N/A	Flare Slope LT (%)	N/A	N/A	Flare Slope RT (%)	N/A
N/A	Flare Traversable LT?	N/A	N/A	Flare Traversable RT?	N/A
N/A	Landing Length (in)	N/A	N/A	DWS Provided?	N/A
N/A	Landing Width (in)	N/A	N/A	DWS Contrast?	N/A
N/A	Landing Slope (%)	N/A	N/A	DWS Length (in)	N/A
N/A	Landing X Slope (%)	N/A	N/A	DWS Full Width?	N/A
N/A	Landing Curb? (Y/N)	N/A	N/A	DWS Offset (in)	N/A
N/A	Shared Landing?	N/A			
N/A	Gutter Ponding?	N/A	N/A	Gutter Slope (%)	N/A
N/A	Gutter Lip Ht (in)	2.0	N/A	Gutter X Slope (%)	N/A
N/A	Painted X Walk1?	No	N/A	Painted X Walk2?	N/A
	X Walk 1 Direction	To SW		X Walk 2 Direction	N/A
N/A	X Walk 1 Width (in)	N/A	N/A	X Walk 2 Width (in)	N/A
	X Walk 1 Slope (%)	3.0		X Walk 2 Slope (%)	N/A
	X Walk 1 X Slope (%)	2.7		X Walk 2 X Slope (%)	N/A

N/A	Ramp inside XWalk1?	N/A	N/A	Ramp inside XWalk2?	N/A
	Road Slope (%)	N/A	N/A	Clear Space?	N/A
	Road X Slope (%)	N/A	N/A	Clear Space to XWalk (in)	N/A
N/A	Any Obstructions?	N/A	N/A	Storm Grate/Utility Hazard?	N/A
	Obstruction Type			Storm Grate/Utility Type	
		N/A			N/A
			Yes	Surface Condition? (G/P)	Good

Possible Solutions:

Remove & Replace Entire Ramp.

R304.5.1
