Intersection ID: 10952	Main Street: N_GRAHAM_ST	Cross Street: STATESVILLE_AV	Location:	NW
ADA ID: A2F955FE5662	Ramp Type: Perp	Initial Pass/Fail: Fail	Overall Compliance: No	Severity Score: 13.75

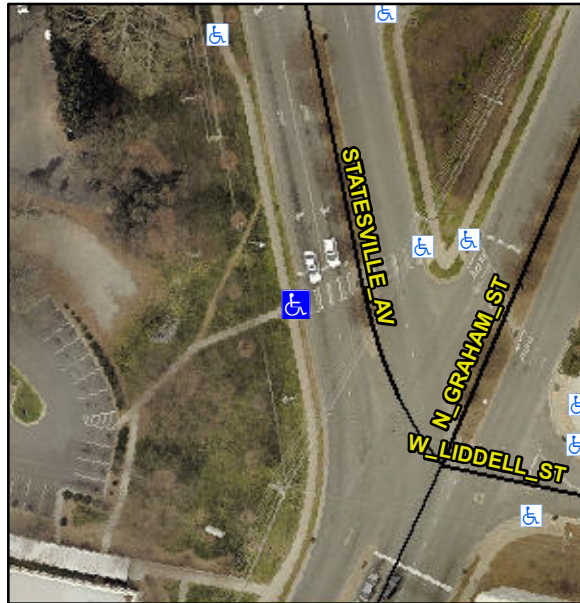
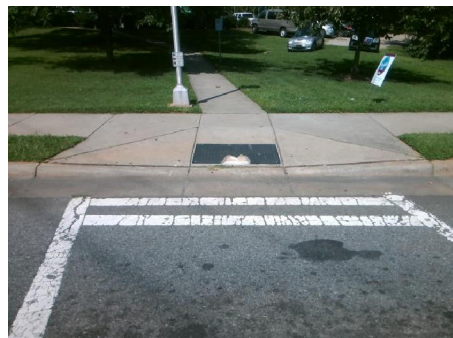
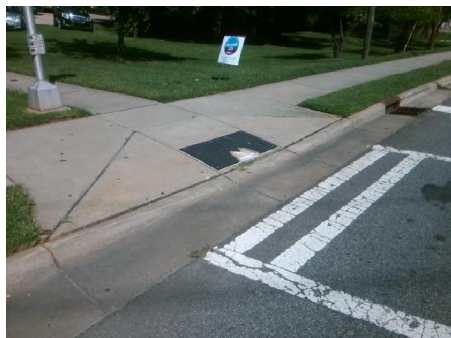
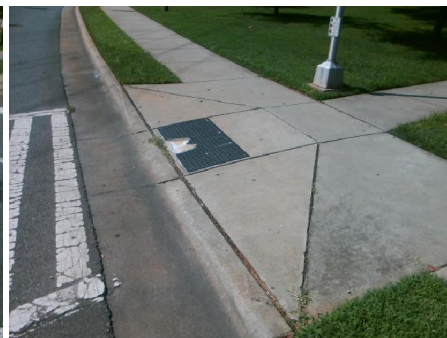
Not Found, R304.2.2, R304.5.3

Compliance	Description	Data	Compliance	Description	Data
N/A	Ramp Length (in)	58.5	No	Ramp Slope (%)	10.8
Yes	Ramp Width (in)	48.5	No	Ramp XSlope (%)	2.9
N/A	Flare Type LT	N/A	N/A	Flare Type RT	N/A
N/A	Flare Slope LT (%)	N/A	N/A	Flare Slope RT (%)	N/A
N/A	Flare Traversable LT?	N/A	N/A	Flare Traversable RT?	N/A
N/A	Landing Length (in)	N/A	N/A	DWS Provided?	N/A
N/A	Landing Width (in)	N/A	N/A	DWS Contrast?	N/A
N/A	Landing Slope (%)	N/A	N/A	DWS Length (in)	N/A
N/A	Landing X Slope (%)	N/A	N/A	DWS Full Width?	N/A
N/A	Landing Curb? (Y/N)	N/A	N/A	DWS Offset (in)	N/A
N/A	Shared Landing?	N/A			
N/A	Gutter Ponding?	N/A	N/A	Gutter Slope (%)	N/A
N/A	Gutter Lip Ht (in)	N/A	N/A	Gutter X Slope (%)	N/A
N/A	Painted X Walk1?	Yes	N/A	Painted X Walk2?	N/A
	X Walk 1 Direction	To E		X Walk 2 Direction	N/A
N/A	X Walk 1 Width (in)	123.0	N/A	X Walk 2 Width (in)	N/A
	X Walk 1 Slope (%)	1.6		X Walk 2 Slope (%)	N/A
	X Walk 1 X Slope (%)	1.8		X Walk 2 X Slope (%)	N/A

N/A	Ramp inside XWalk1?	Yes	N/A	Ramp inside XWalk2?	N/A
	Road Slope (%)	N/A	N/A	Clear Space?	N/A
	Road X Slope (%)	N/A	N/A	Clear Space to XWalk (in)	N/A
N/A	Any Obstructions?	N/A	N/A	Storm Grate/Utility Hazard?	N/A
	Obstruction Type			Storm Grate/Utility Type	
		N/A			N/A
			Yes	Surface Condition? (G/P)	Good

Remove & Replace Entire Ramp.

Total Cost: \$ 1850.00
