Access Compliance Report

Public Rights-of-Way

(Curb Ramps)

Intersection ID: 48634	Main Street: GRANDE_HEIGHTS_DR	Cross Street: DOMINION_CREST_DR	Location: SE
ADA ID: A30210F002A7	Ramp Type: Perp	Initial Pass/Fail: Fail	Overall Compliance: No
Severity Score: 12.5			
Codes/Mitigation Info/Possible Solution		Field Measurements/Component Compliance

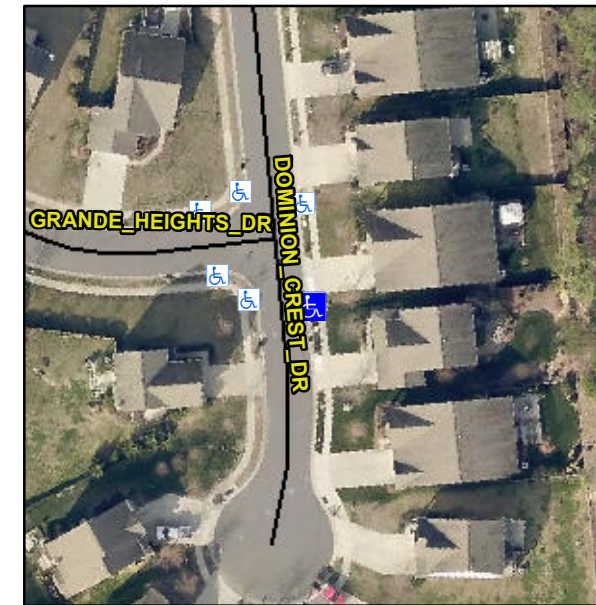
Not Found, R304.2.2

Compliance	Description	Data	Compliance	Description	Data
N/A	Ramp Length (in)	47.0	No	Ramp Slope (%)	8.9
Yes	Ramp Width (in)	48.0	Yes	Ramp XSlope (%)	1.4
N/A	Flare Type LT	N/A	N/A	Flare Type RT	N/A
N/A	Flare Slope LT (%)	N/A	N/A	Flare Slope RT (%)	N/A
N/A	Flare Traversable LT?	N/A	N/A	Flare Traversable RT?	N/A
N/A	Landing Length (in)	N/A	N/A	DWS Provided?	N/A
N/A	Landing Width (in)	N/A	N/A	DWS Contrast?	N/A
N/A	Landing Slope (%)	N/A	N/A	DWS Length (in)	N/A
N/A	Landing X Slope (%)	N/A	N/A	DWS Full Width?	N/A
N/A	Landing Curb? (Y/N)	N/A	N/A	DWS Offset (in)	N/A
N/A	Shared Landing?	N/A			
N/A	Gutter Ponding?	N/A	N/A	Gutter Slope (%)	N/A
N/A	Gutter Lip Ht (in)	N/A	N/A	Gutter X Slope (%)	N/A
N/A	Painted X Walk1?	No	N/A	Painted X Walk2?	N/A
	X Walk 1 Direction	To W		X Walk 2 Direction	N/A
N/A	X Walk 1 Width (in)	N/A	N/A	X Walk 2 Width (in)	N/A
	X Walk 1 Slope (%)	4.1		X Walk 2 Slope (%)	N/A
	X Walk 1 X Slope (%)	2.3		X Walk 2 X Slope (%)	N/A

Possible Solutions:

Remove & Replace Entire Ramp.
