Access Compliance Report

Public Rights-of-Way

(Curb Ramps)

Intersection ID: 11835	Main Street: BELMONT_AV	Cross Street: N_DAVIDSON_ST	Location: S
ADA ID: A30DCB47A012	Ramp Type: PerpDiag	Initial Pass/Fail: Fail	Overall Compliance: No
Severity Score: 13.75			
Codes/Mitigation Info/Possible Solution		Field Measurements/Component Compliance

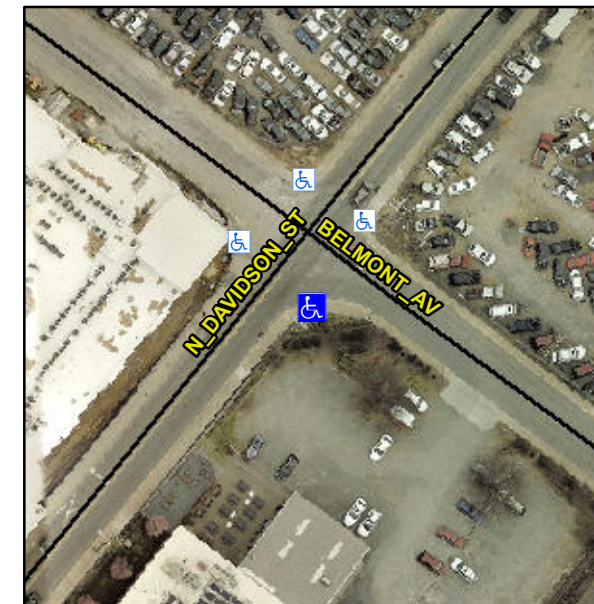
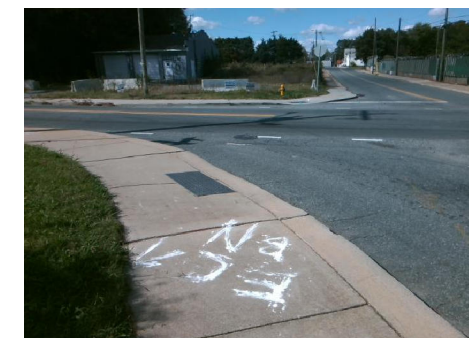
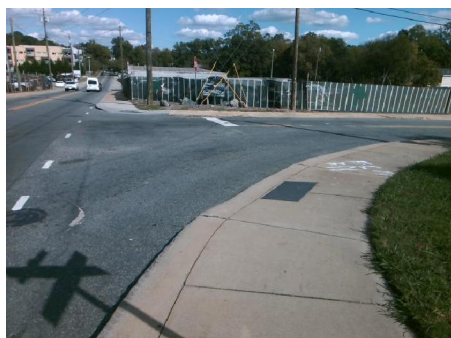
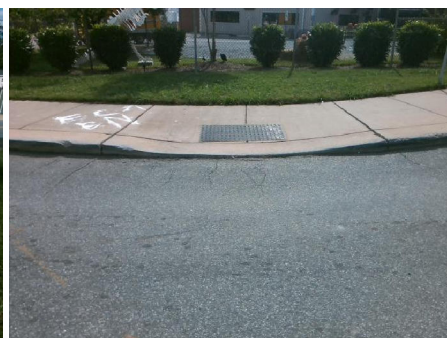
Not Found, R304.2.2, R304.5.3

Compliance	Description	Data	Compliance	Description	Data
N/A	Ramp Length (in)	66.0	No	Ramp Slope (%)	10.8
Yes	Ramp Width (in)	59.0	No	Ramp XSlope (%)	4.9
N/A	Flare Type LT	N/A	N/A	Flare Type RT	N/A
N/A	Flare Slope LT (%)	N/A	N/A	Flare Slope RT (%)	N/A
N/A	Flare Traversable LT?	N/A	N/A	Flare Traversable RT?	N/A
N/A	Landing Length (in)	N/A	N/A	DWS Provided?	N/A
N/A	Landing Width (in)	N/A	N/A	DWS Contrast?	N/A
N/A	Landing Slope (%)	N/A	N/A	DWS Length (in)	N/A
N/A	Landing X Slope (%)	N/A	N/A	DWS Full Width?	N/A
N/A	Landing Curb? (Y/N)	N/A	N/A	DWS Offset (in)	N/A
N/A	Shared Landing?	N/A			
N/A	Gutter Ponding?	N/A	N/A	Gutter Slope (%)	N/A
N/A	Gutter Lip Ht (in)	N/A	N/A	Gutter X Slope (%)	N/A
N/A	Painted X Walk1?	No	N/A	Painted X Walk2?	No
	X Walk 1 Direction	To NE		X Walk 2 Direction	To NW
N/A	X Walk 1 Width (in)	N/A	N/A	X Walk 2 Width (in)	N/A
	X Walk 1 Slope (%)	1.7		X Walk 2 Slope (%)	3.6
	X Walk 1 X Slope (%)	3.3		X Walk 2 X Slope (%)	1.3

N/A	Ramp inside XWalk1?	N/A	N/A	Ramp inside XWalk2?	N/A
	Road Slope (%)	3.7	N/A	Clear Space?	N/A
	Road X Slope (%)	0.6	N/A	Clear Space to XWalk (in)	N/A
N/A	Any Obstructions?	N/A	N/A	Storm Grate/Utility Hazard?	N/A
	Obstruction Type			Storm Grate/Utility Type	
		N/A			N/A
		Yes		Surface Condition? (G/P)	Good

Remove & Replace Curb Ramp With Two New Directional Ramps or Equivalent.
