# Access Compliance Report

## Public Rights-of-Way

### (Curb Ramps)

Intersection ID: 46500	Main Street: NEWBRIDGE_RD	Cross Street: ROCK_ISLAND_RD	Location: NW
ADA ID: A3175BF3ADA1	Ramp Type: PerpDiag	Initial Pass/Fail: Fail	Overall Compliance: No
		Severity Score: 22.5

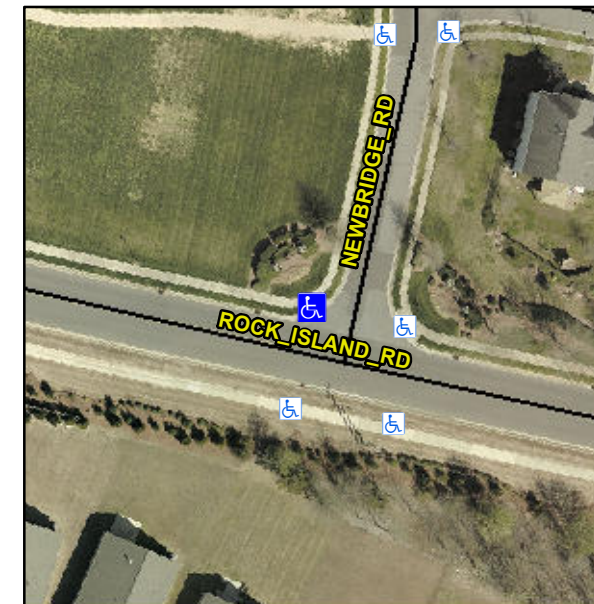
**R304.5.1, R304.2.2, R304.5.3**

Compliance	Description	Data	Compliance	Description	Data
N/A	Ramp Length (in)	50.0	No	Ramp Slope (%)	10.0
No	Ramp Width (in)	47.5	No	Ramp XSlope (%)	3.9
N/A	Flare Type LT	N/A	N/A	Flare Type RT	N/A
N/A	Flare Slope LT (%)	N/A	N/A	Flare Slope RT (%)	N/A
N/A	Flare Traversable LT?	N/A	N/A	Flare Traversable RT?	N/A
N/A	Landing Length (in)	N/A	N/A	DWS Provided?	N/A
N/A	Landing Width (in)	N/A	N/A	DWS Contrast?	N/A
N/A	Landing Slope (%)	N/A	N/A	DWS Length (in)	N/A
N/A	Landing X Slope (%)	N/A	N/A	DWS Full Width?	N/A
N/A	Landing Curb? (Y/N)	N/A	N/A	DWS Offset (in)	N/A
N/A	Shared Landing?	N/A			
N/A	Gutter Ponding?	N/A	N/A	Gutter Slope (%)	N/A
N/A	Gutter Lip Ht (in)	N/A	N/A	Gutter X Slope (%)	N/A
N/A	Painted X Walk1?	No	N/A	Painted X Walk2?	No
	X Walk 1 Direction	To SW		X Walk 2 Direction	To SE
N/A	X Walk 1 Width (in)	N/A	N/A	X Walk 2 Width (in)	N/A
	X Walk 1 Slope (%)	0.2		X Walk 2 Slope (%)	0.8
	X Walk 1 X Slope (%)	1.0		X Walk 2 X Slope (%)	3.6

N/A	Ramp inside XWalk1?	N/A	N/A	Ramp inside XWalk2?	N/A
	Road Slope (%)	1.1	N/A	Clear Space?	N/A
	Road X Slope (%)	0.5	N/A	Clear Space to XWalk (in)	N/A
N/A	Any Obstructions?	N/A	N/A	Storm Grate/Utility Hazard?	N/A
	Obstruction Type			Storm Grate/Utility Type	
		N/A			N/A
			Yes	Surface Condition? (G/P)	Good

**Remove & Replace Curb Ramp With Two New Directional Ramps or Equivalent.**
